SALAMANDER INSPECTIONS LTD
Mechanical Insulation Energy Audits

Energy Audit

Cairnsmore Place
250 Cairnsmore St.,
Duncan, B.C.
V9L-4H2

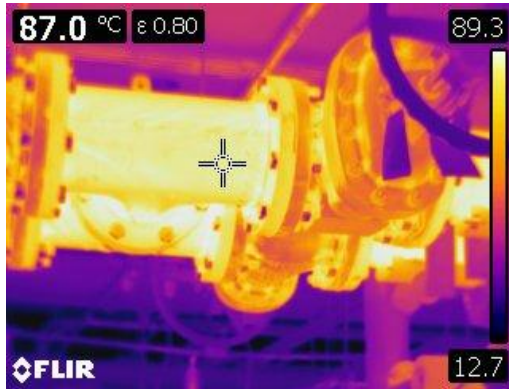
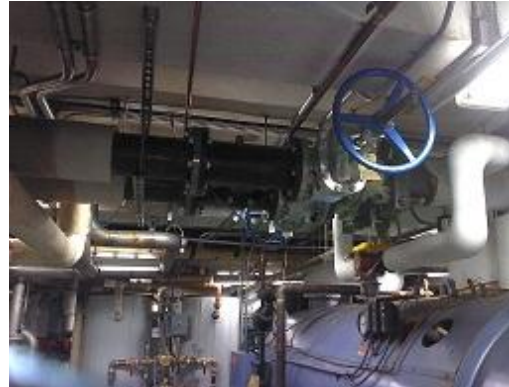
Figure 3 This thermographic image is of bare heating supply lines and valves at 87° C or 188° F.

Figure 4 This is a conventional photo of the same piping and valves from the boilers.

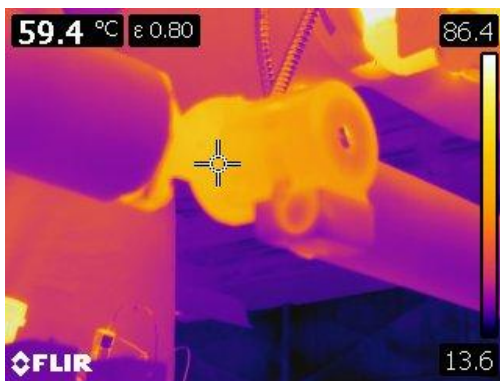
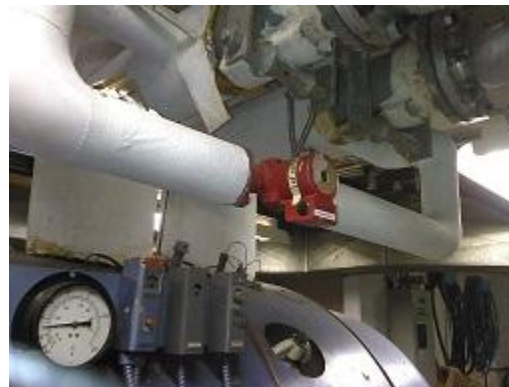
Figure 5 This Thermographic image of a re-circ pump adjacent to boilers.

Figure 6 This conventional photo shows the same re-circ pump at the boilers.

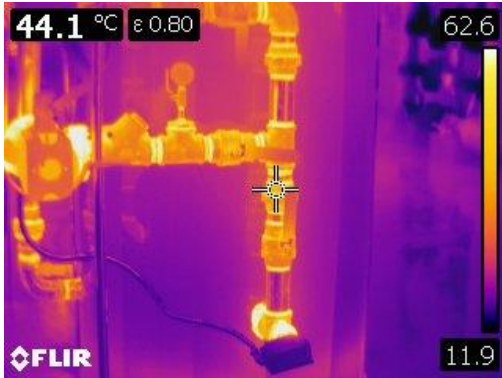
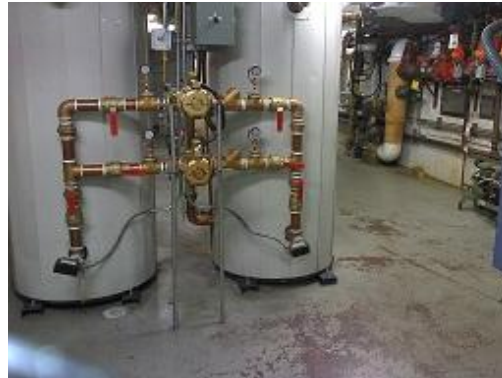
Figure 7 This is a thermographic image of copper pipe at the hot water tanks at 44.1° C or 111° F.

Figure 8 This is a conventional photo of the two heating pump and copper pipe at the hot water tank.

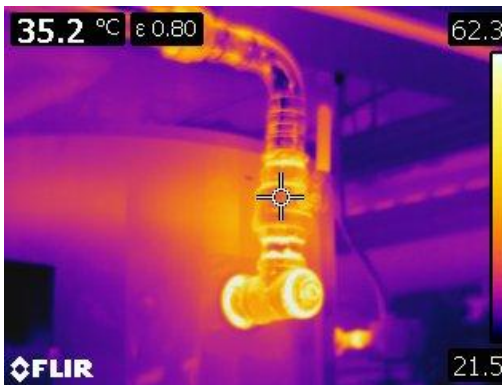
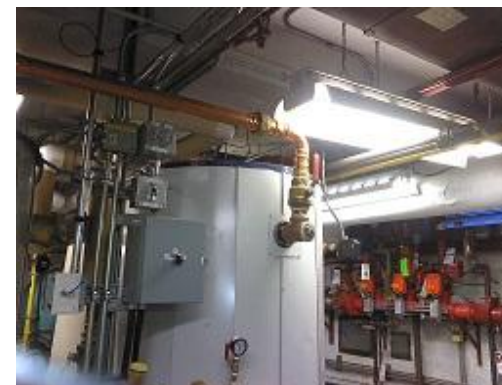
Figure 9 This is a thermographic image of copper pipe heating supply at 35.2° C or 95° F.

Figure 10 This is the conventional image of the same copper line from the hot water tank.

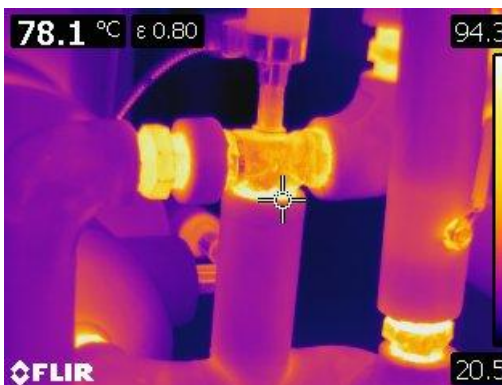
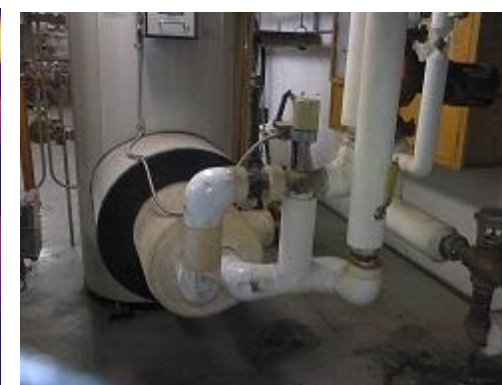
Figure 11 Thermographic image of bare motorized tee and associated fittings at the hot water tanks at 78.1° C or 172° F.

Figure 12 This is a conventional image of the same bare tee's and fittings.

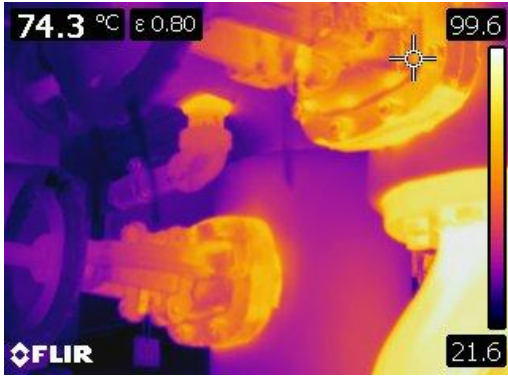
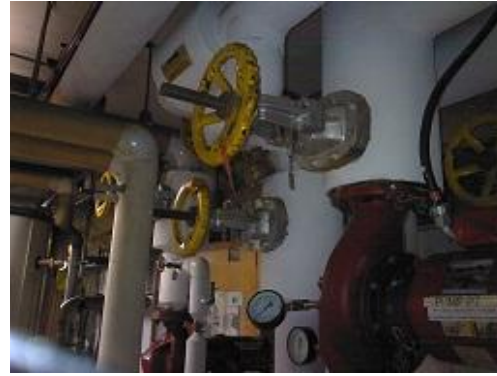
Figure 13 Thermographic image of bare valve bonnets on the heating supply at 74.3° C or 165 F.

Figure 14 Conventional image of the same bare valve bonnets.

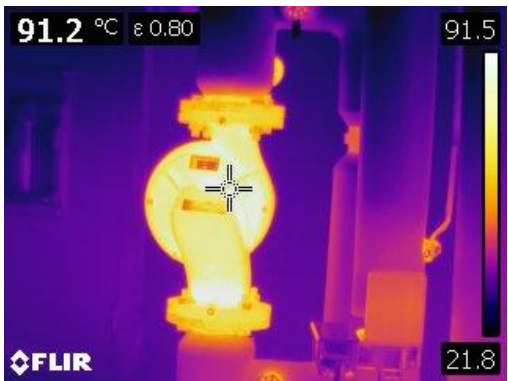
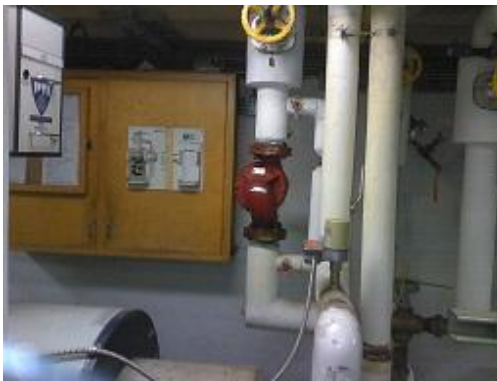
Figure 15 Thermographic image of a motorized heating pump at 91.2° C or 196 F.

Figure 16 Conventional image of the heating pump.

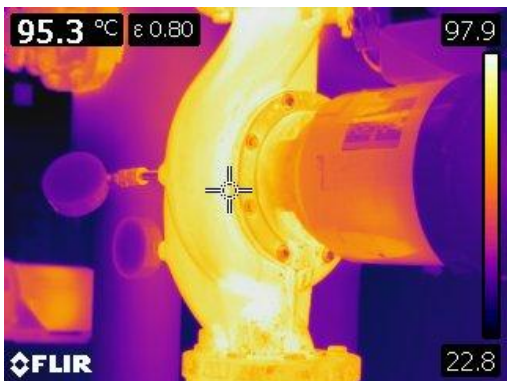
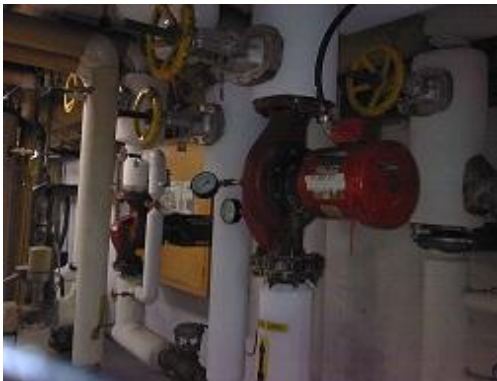
Figure 17 Thermographic image of motorized pump at 95.3° C or 203° F.

Figure 18 Conventional picture of the same motorized pump.

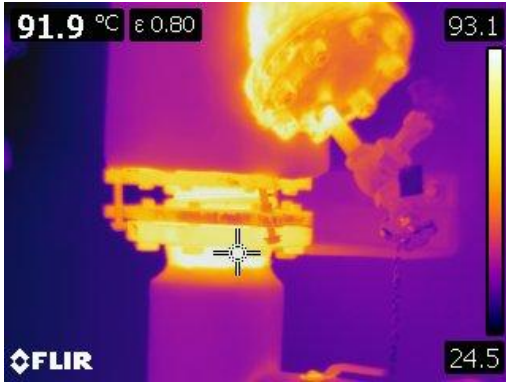
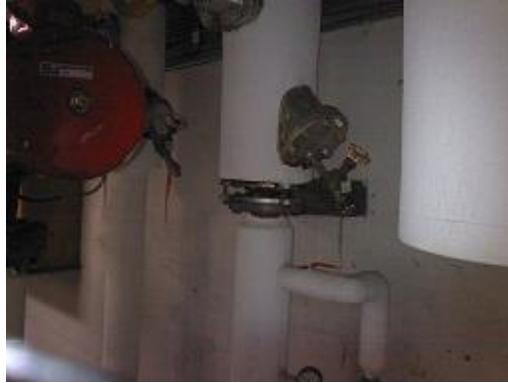
Figure 19 Thermographic image of a bare flange and strainer 91.9° C or 197° F.

Figure 20 Conventional image of the same flange and strainer.

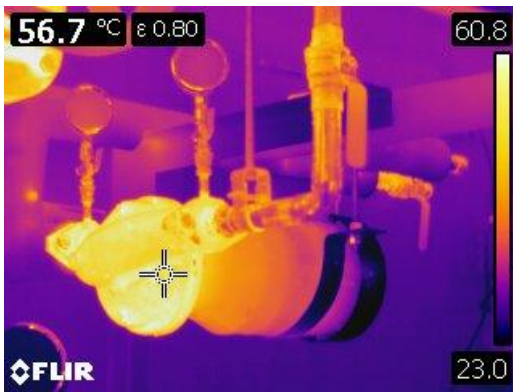
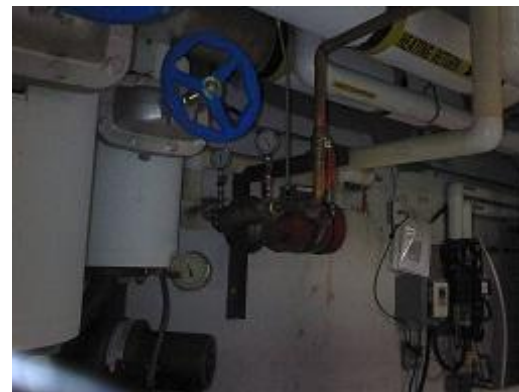
Figure 21 Thermographic image of a motorized heating pump at 56.7° C or 134° F.

Figure 22 conventional image of the same motorized pump.

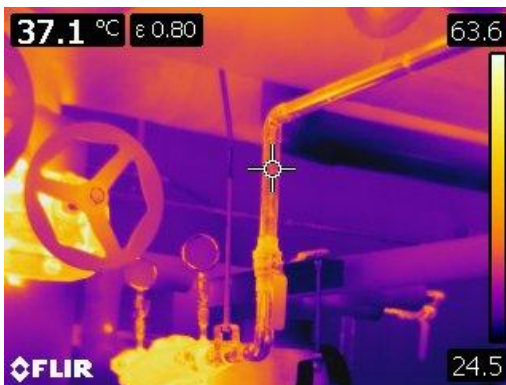
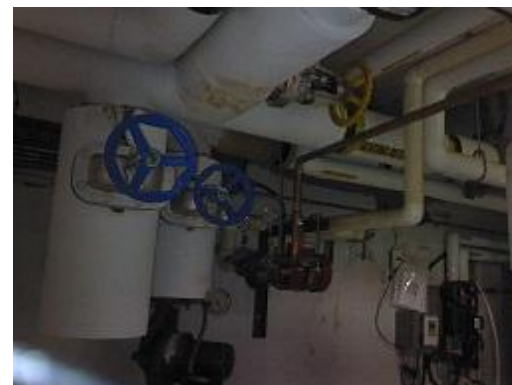
Figure 23 Thermographic image of a copper line from heating pump at 37.1° C or 98° F.

Figure 24 Conventional image of the same copper line from pump.

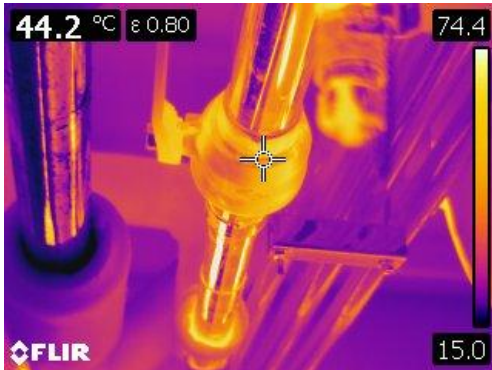
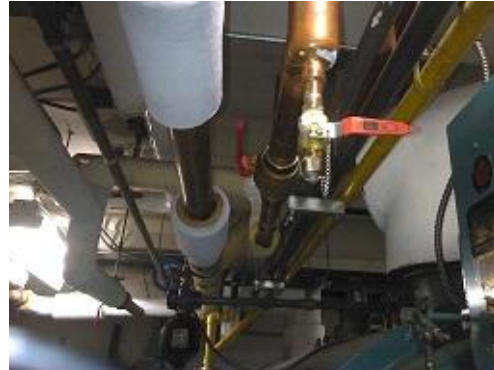
Figure 25 Thermographic image of bare copper piping at 44.2° C or 111° F.

Figure 26 Conventional image of the same copper piping and valve.

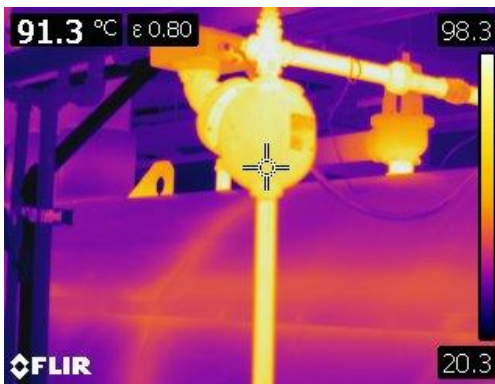
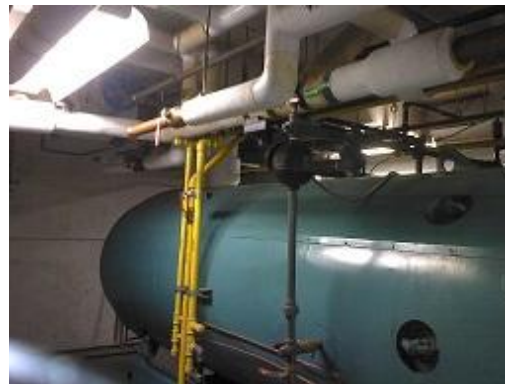
Figure 27 Thermographic image of pressure relief piping from the boiler at 91.3° C or 196° F.

Figure 28 Conventional image of the same piping from boiler.

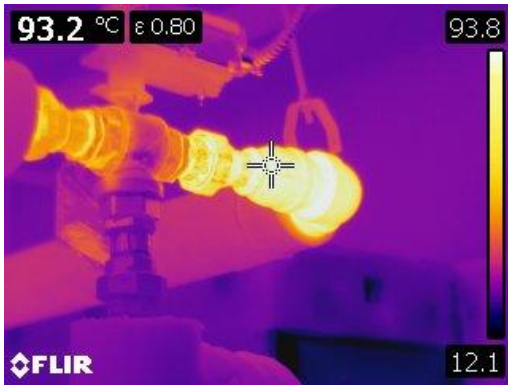
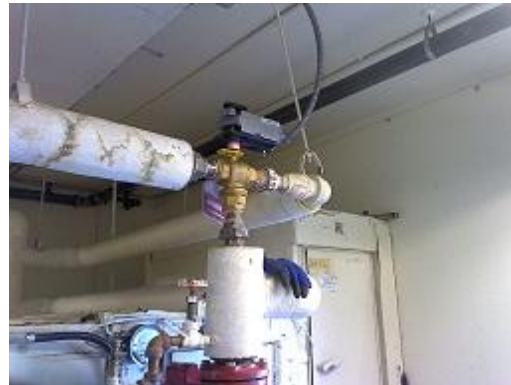
Figure 29 Thermographic image of bare motorized Tee at 93.2° C or 199° F.

Figure 30 Thermographic image of the same bare motorized Tee.

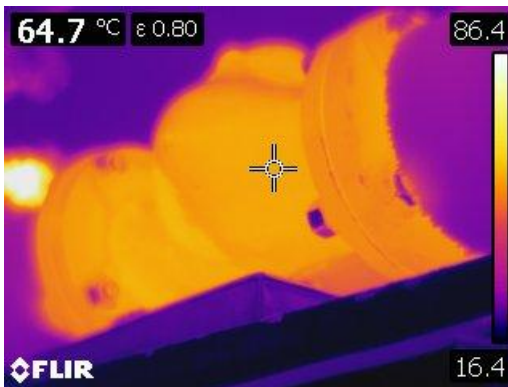
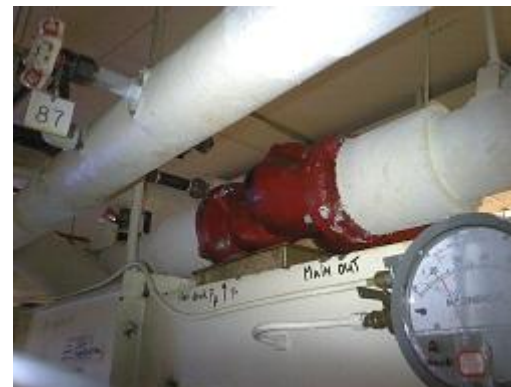
Figure 31 Thermographic image of bare motorized heating pump at 93.2° C or 199° F .

Figure 32 Conventional image of the same motorized heating pump.

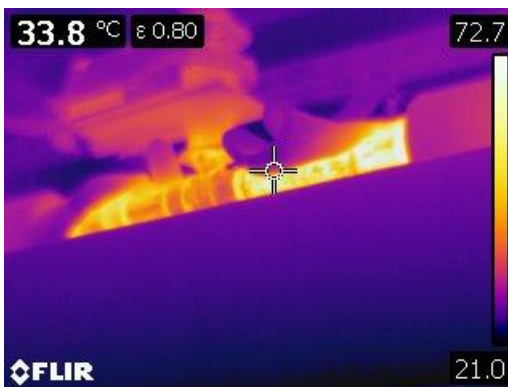
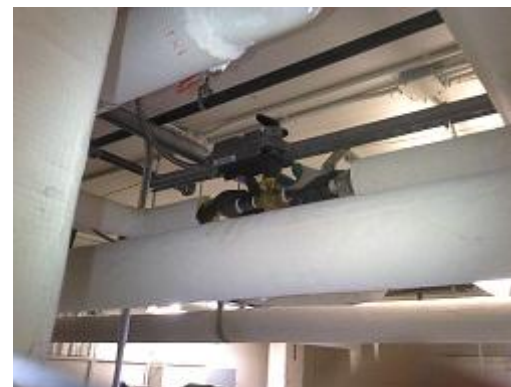
Figure 33 Thermographic image of motorized valve and pipe at 33.8° C or 92° F .

Figure 34 Conventional image of the same valve and pipe.
