SALAMANDER INSPECTIONS LTD
Mechanical Insulation Energy Audits

Energy Audit

April 6, 2016

The OS Longman Laboratory Building is located at 6909 – 116 Street, Edmonton Alberta. This building comprises governmental testing services.

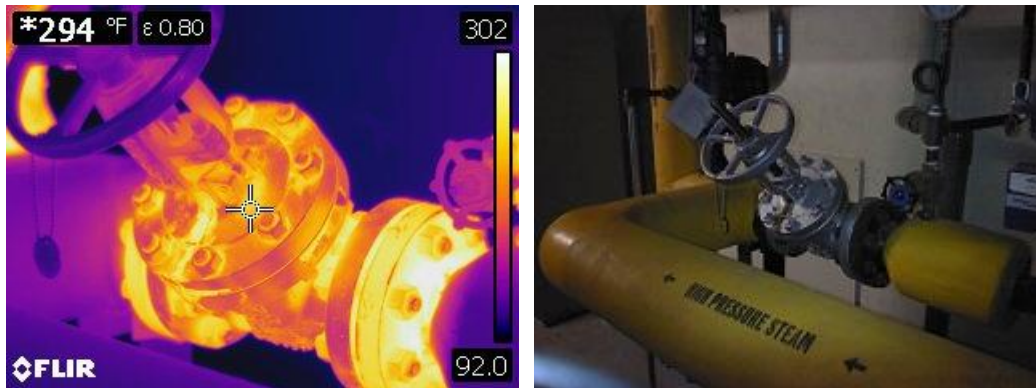
Bare steam valves in the 2nd floor mechanical room at the OS Longman building.

This bare steam valve, as photographed by the FLIR camera uses sensors within the camera to show the heat radiating from the valve. The brighter the color the hotter the temperature of the object. The camera must be set up to filter out the ambient heat from surrounding objects to ensure that the temperatures are accurate. The camera then takes a thermal image as well as a digital picture for reference.

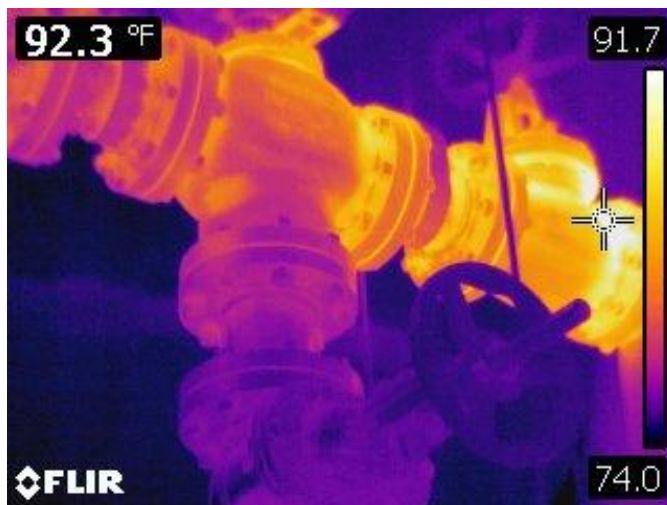
There are some areas where pumps, valves and piping remain without insulation applied.

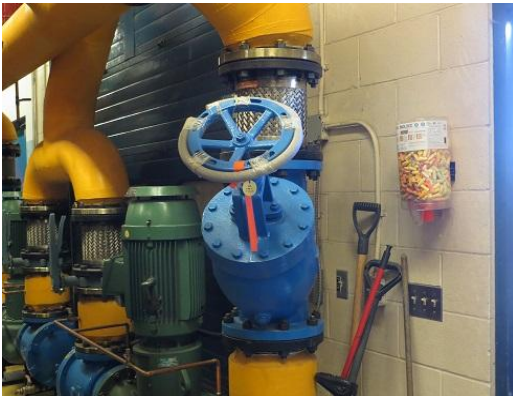
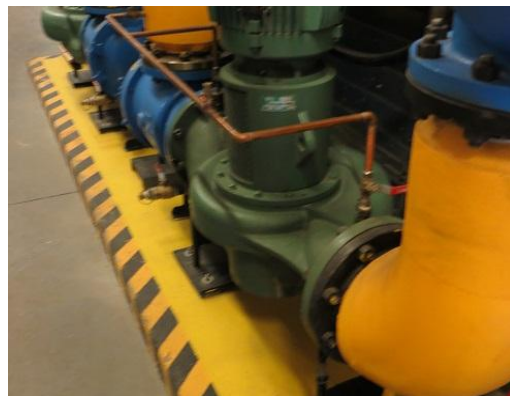
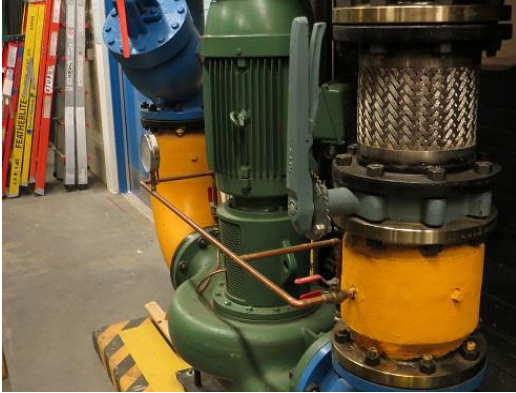
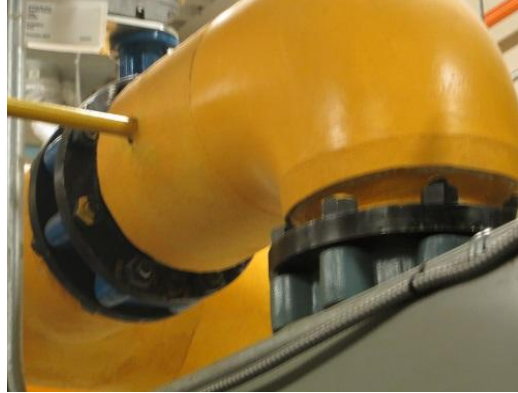
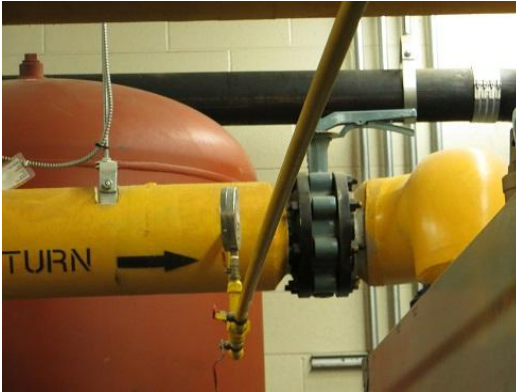
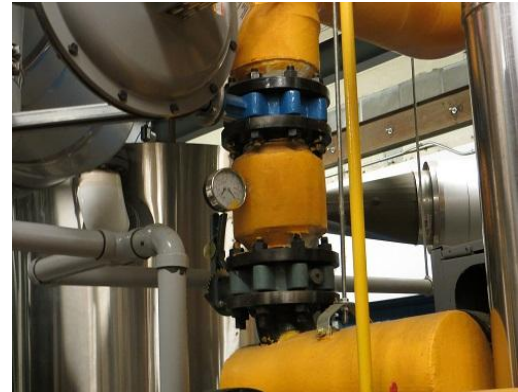
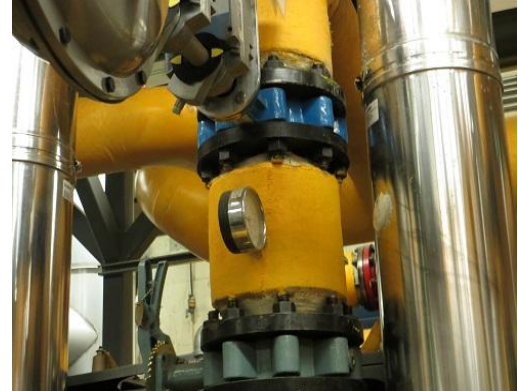
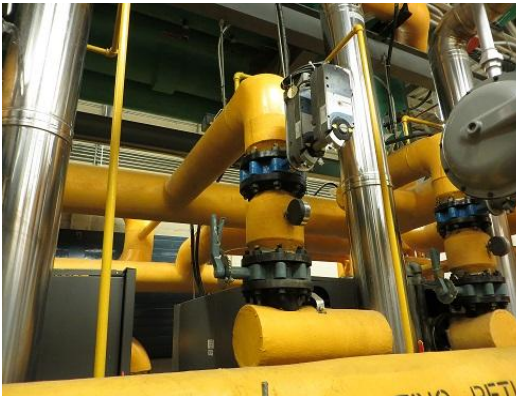
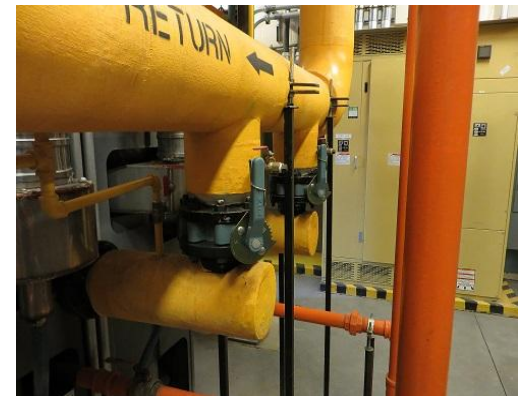
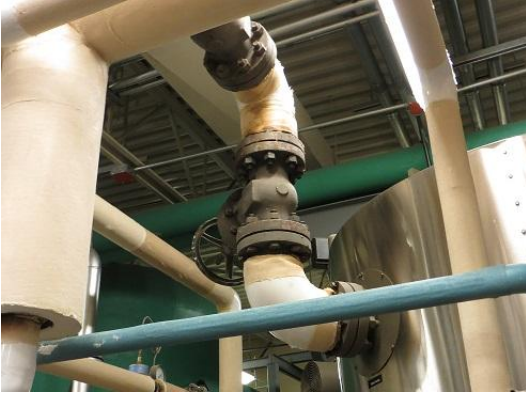
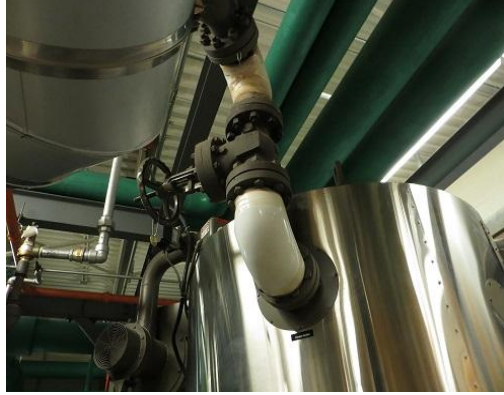
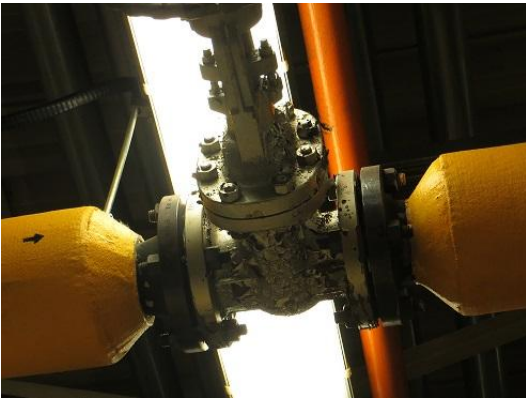
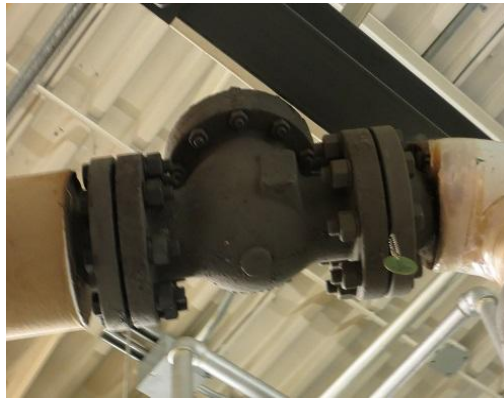
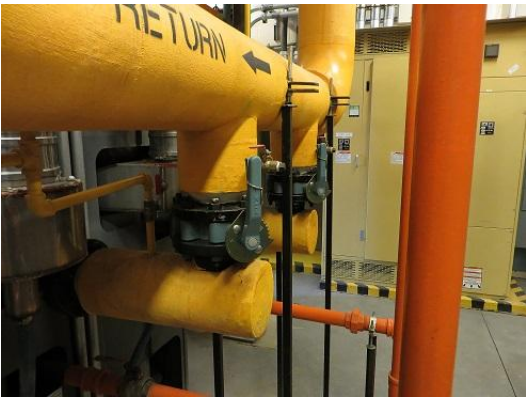
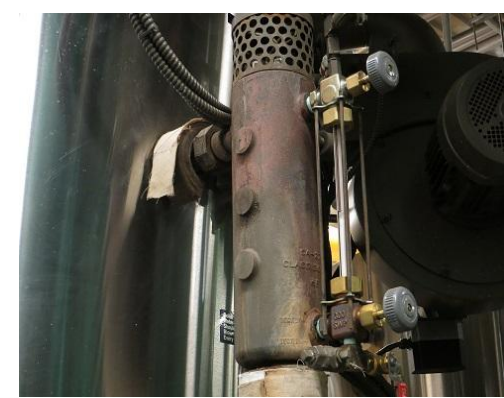
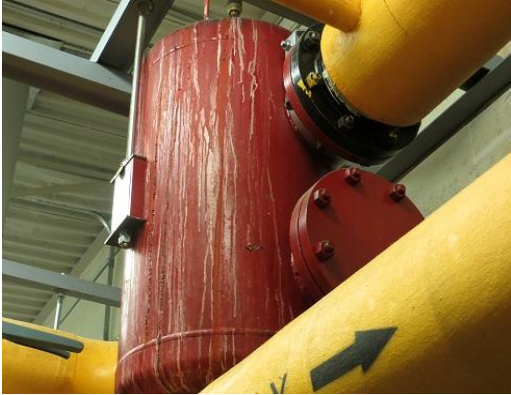
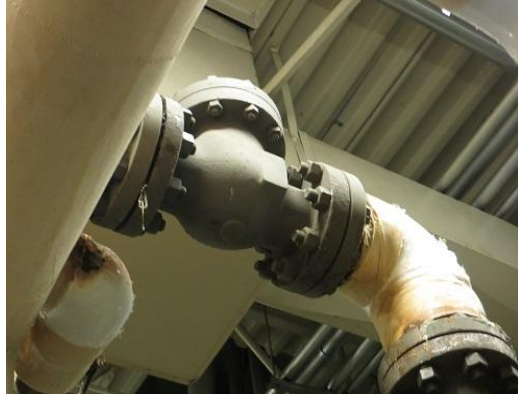
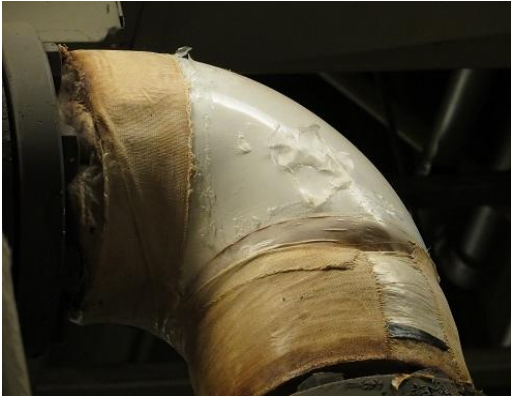
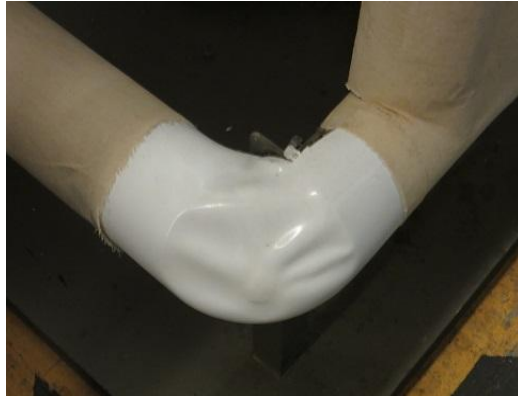
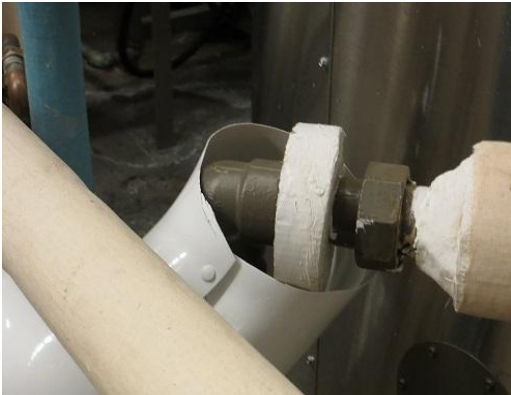
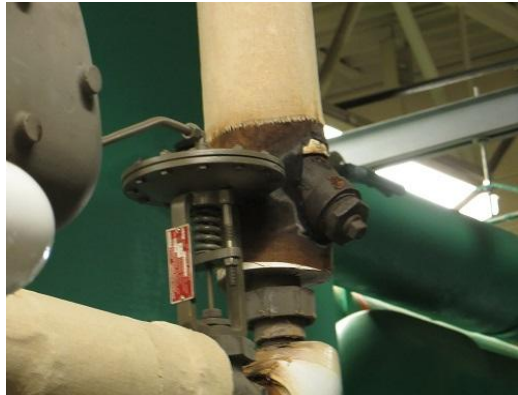
Boiler Room

We have assessed the boiler room and found that the insulation applied to the mechanical systems is in good condition. However, there are some instances where pumps, valves and piping have no insulation applied and therefore, an opportunity to receive some savings is available.

The workmanship of the existing insulation is in good condition but some bad practices were followed when these materials were installed. During the course of this inspection we counted at least (24) valves, (2) strainers, (4) pumps and a number of flanges and couplings as well as and other areas which are not insulated. We also found areas where there isn't any insulation under the PVC fittings, they are literally melted to the pipe. There isn't a good reason to not insulate valves, piping and or fittings but to achieve cost savings at the time of construction or a specification which allowed these practices to take place. We can now show that not insulating pipes hot or cold will cost money for the operation of the building and or repairs to equipment or piping. The report contains visual inspection of these systems utilizing thermographic analysis and conventional digital photographs for reference.

The boiler house at the facility is losing 1,012 GJ per year.

Looking at the work done in the boiler room there appears to be two different contractors doing the work. There are areas of mechanical around the steam boilers that are not finished properly. The temperature of the lines coming off the boilers approach 148C, if you look closely at the pictures you can see burnt canvas and melted PVC elbows from lack of insulation underneath.

Upon consideration of all observed conditions and the information gathered from the 3EPlus program, we recommend that all areas identified within this report be insulated or repaired. We also recommend that **Best Practices** be followed when applying insulation to these items as any deviation from applying insulation will reduce any potential savings. For example, we know that the elimination of canvas can shorten the lifespan of fiberglass with an ASJ finish because of the lack of a protective cladding system. We also recommend using removable insulating pads where necessary or feasible. This will allow maintenance to take place by removing the insulation pad whenever maintenance needs to take place.

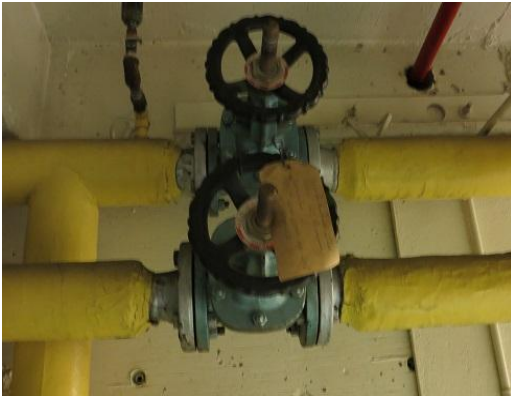
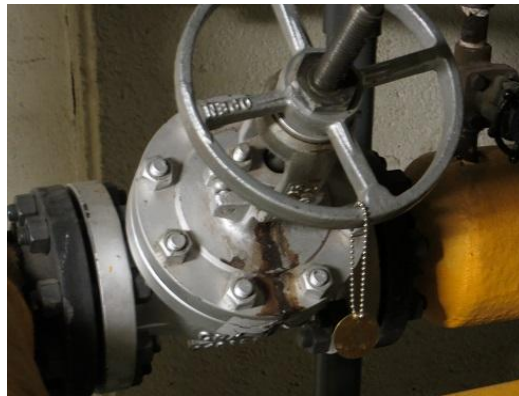
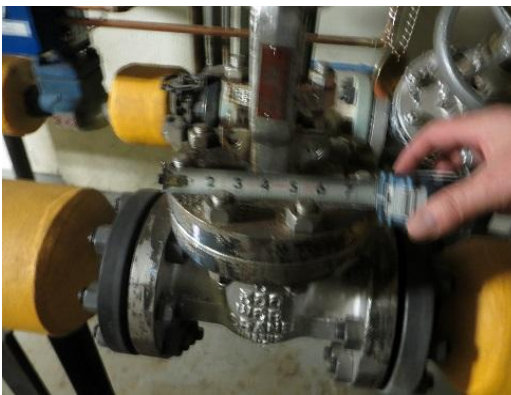
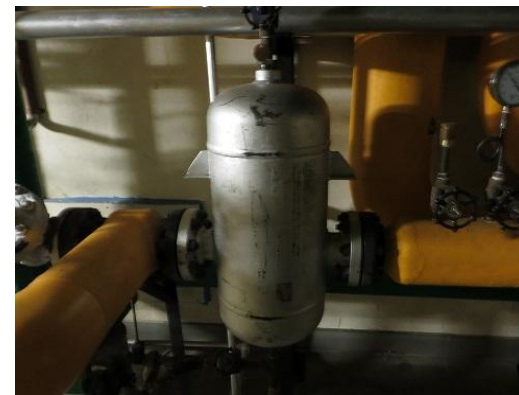
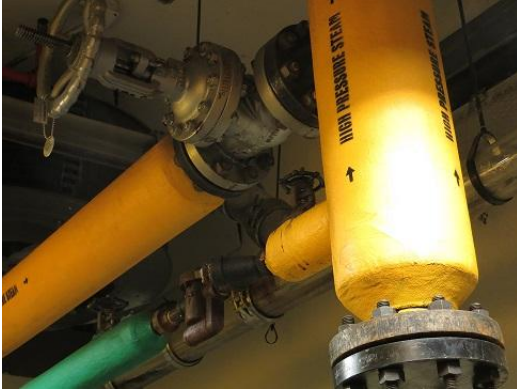
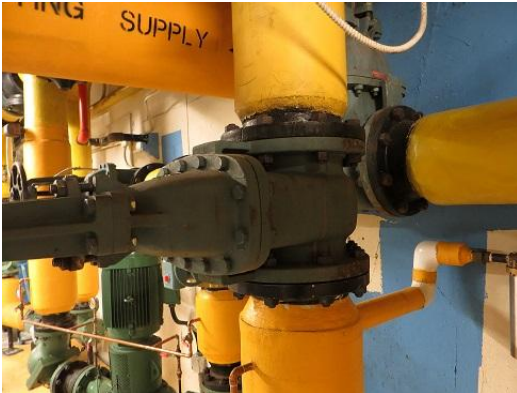
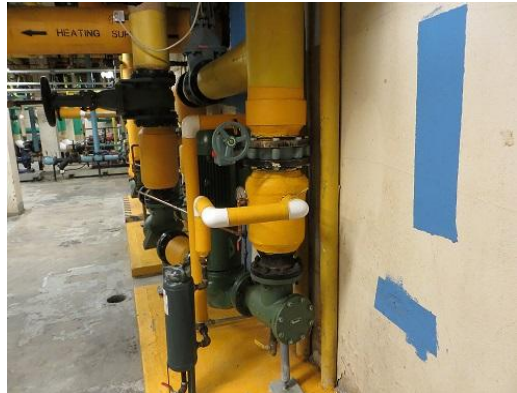
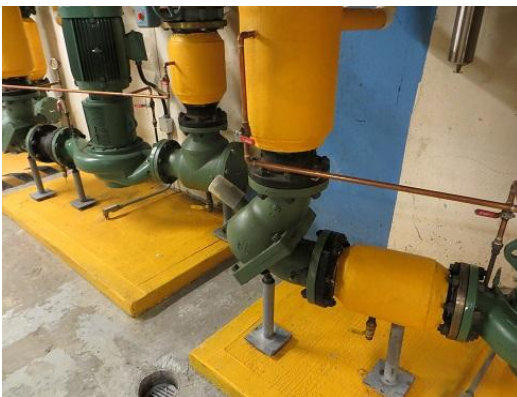
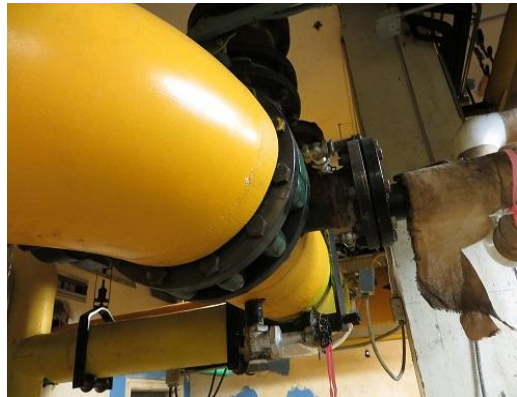
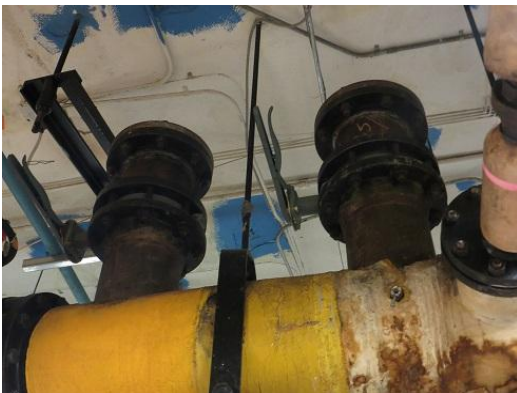
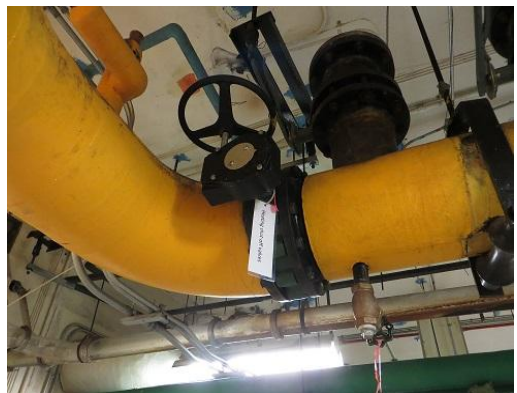
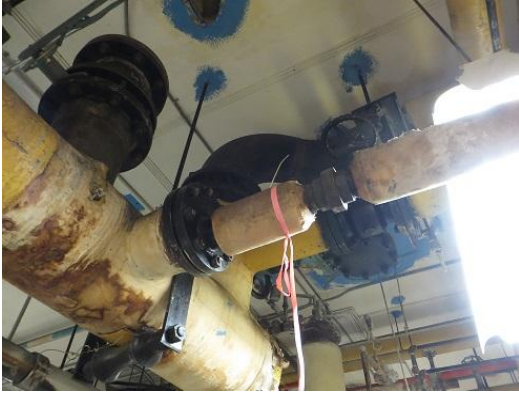
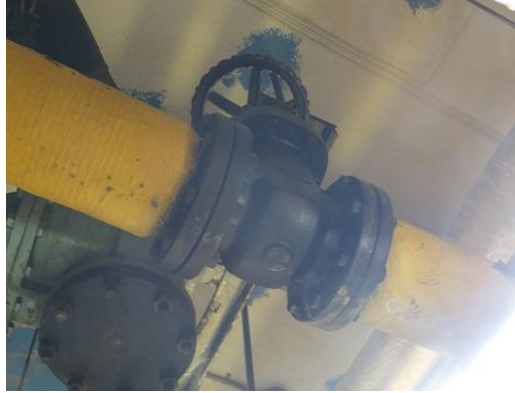
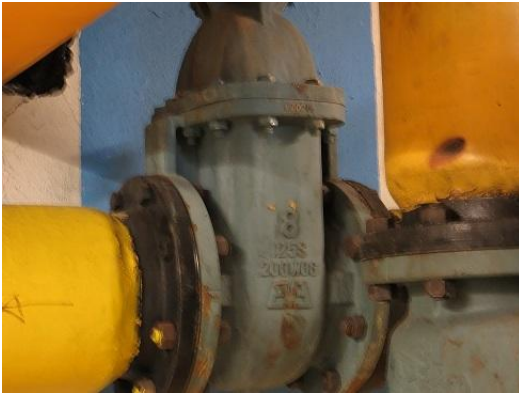
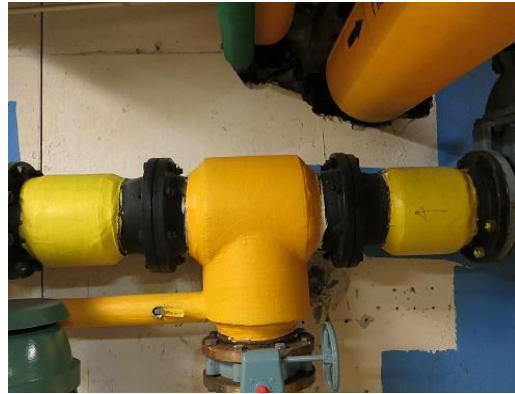
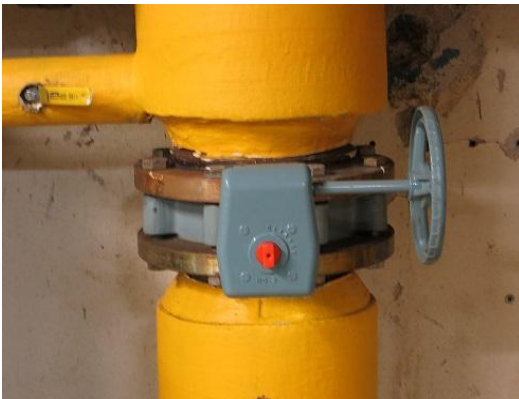
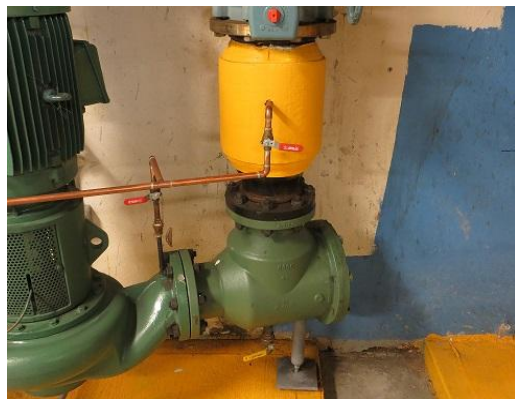
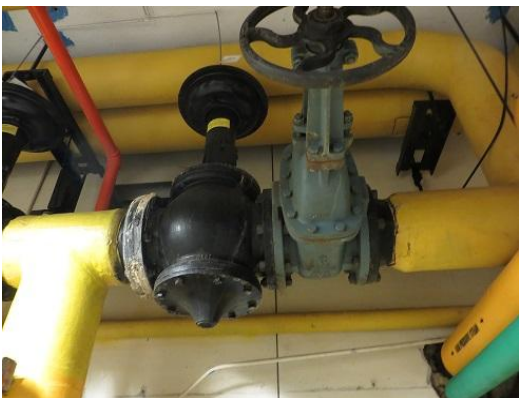
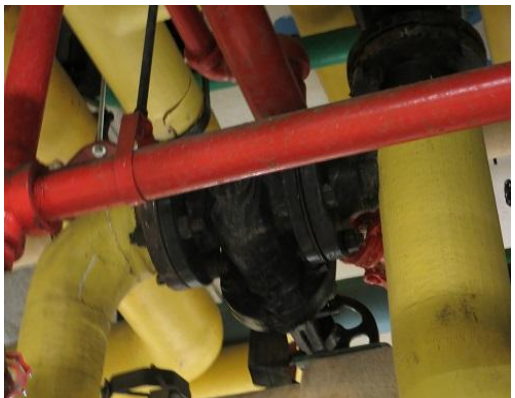
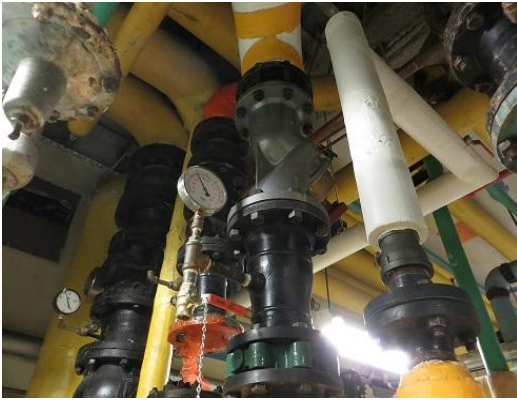
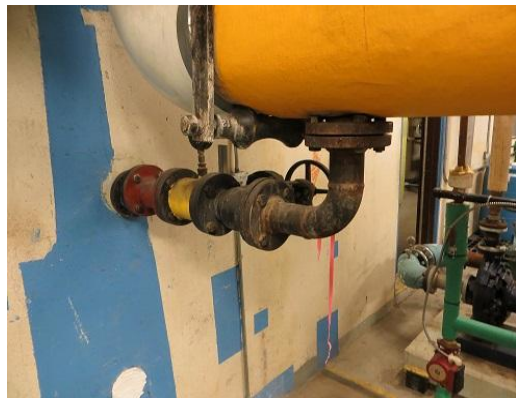
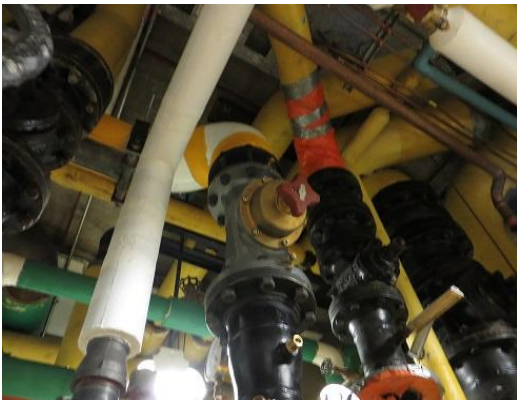
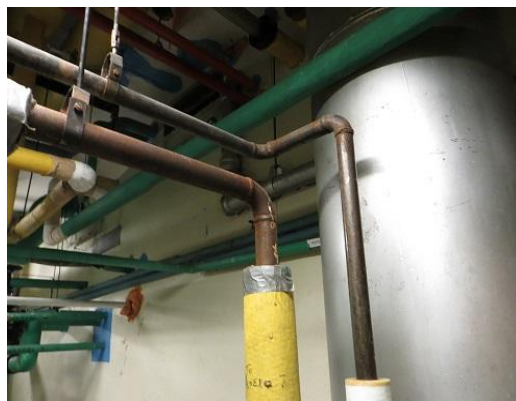
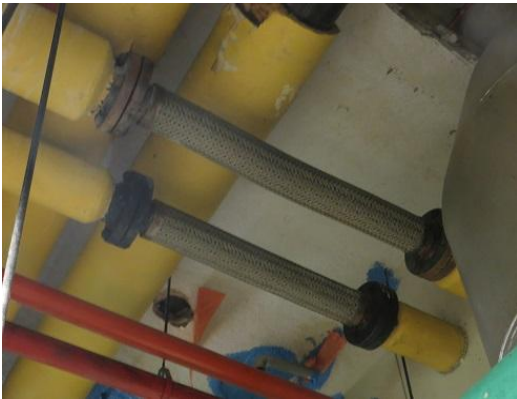
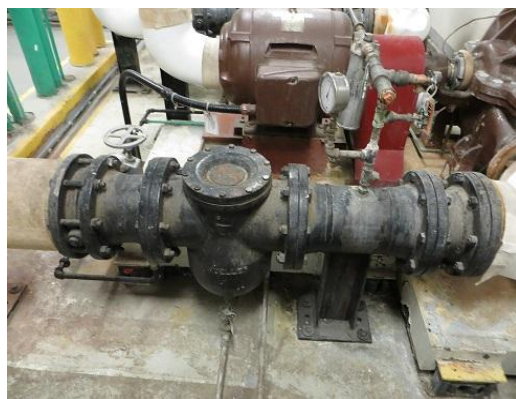
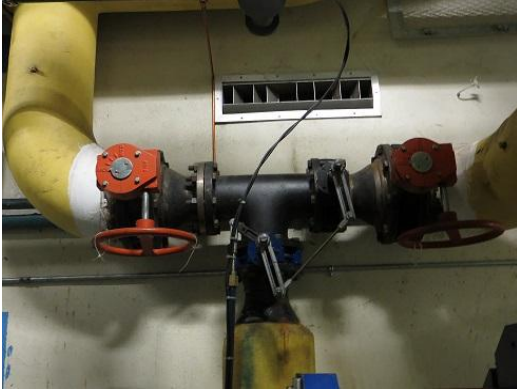
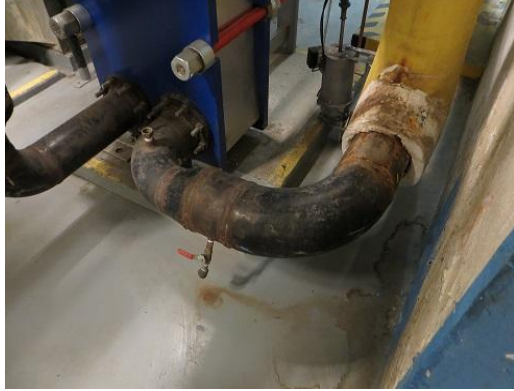
Mechanical Room 2nd floor

We have walked through and inspected the mechanical room on the second floor and found numerous areas which will require insulation to be applied to achieve thermal efficiency. The overall workmanship is good but as seen in other areas insulation has not been applied to any valves, strainers, pumps or heat exchangers. There are areas where pipe covering has been removed for maintenance work this material should have been replaced at the time when work was done. There are a number of valves, strainers and pipes which are High Pressure Steam operating at 148C which are contributing to the elevated temperature in this space.

The 2nd floor mechanical room at the facility is losing 4,908 GJ per year.

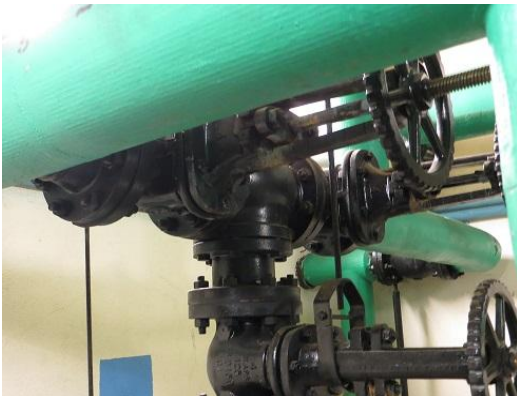
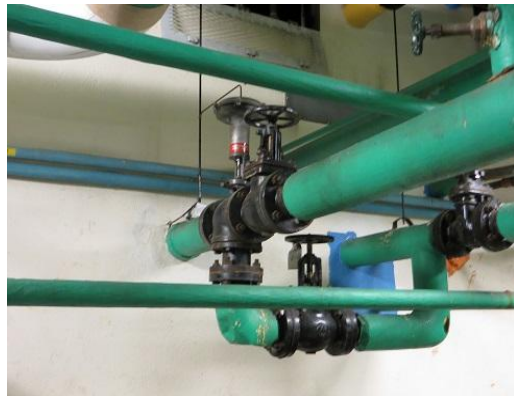
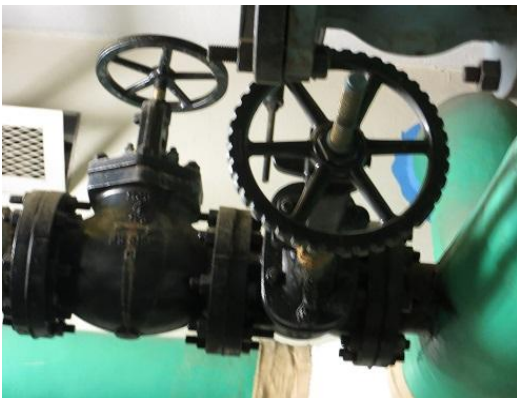
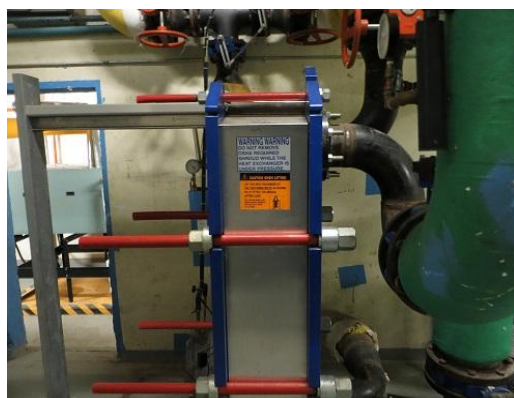
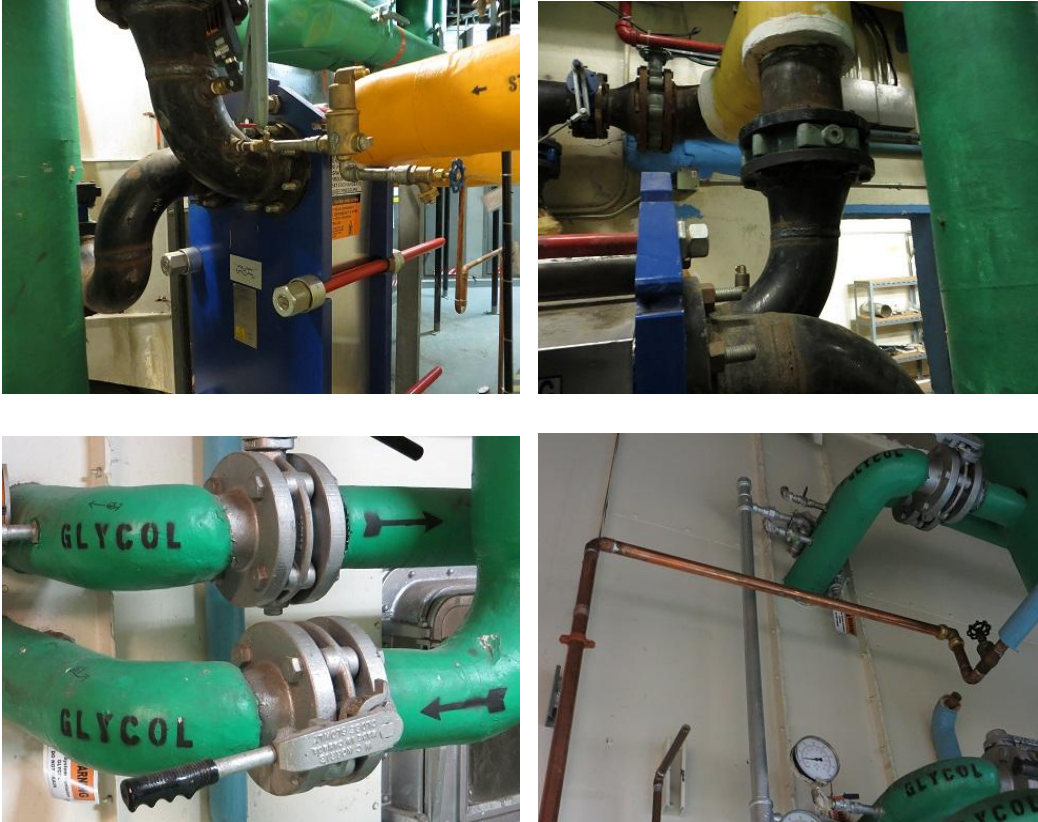
Mechanical Room Glycol System

We have inspected the glycol piping in the 2nd floor mechanical room and found that there are valves, piping, pumps and a heat exchanger that have not been insulated. There are signs of maintenance that have been done and the mechanical insulation has not been repaired or replaced.

The thermographic images which are in the appendix Pictures show very low temperatures for glycol system. There are still many areas on this glycol system that should be insulated to maximize efficiency.

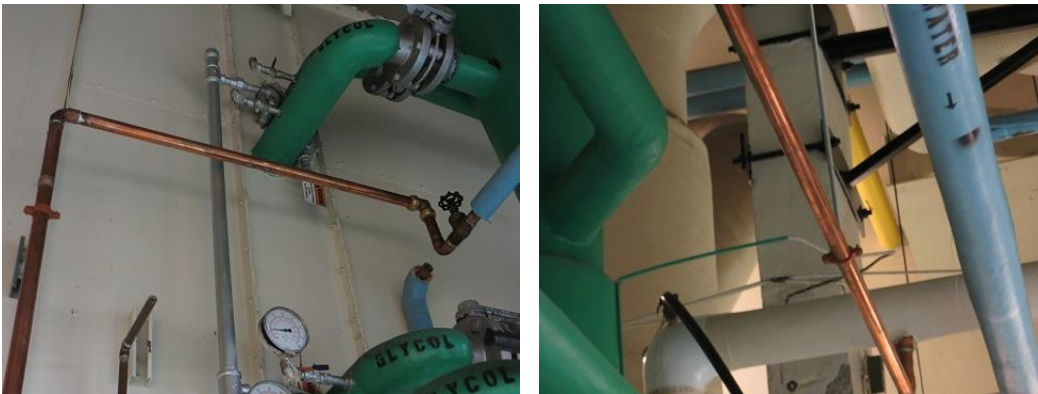
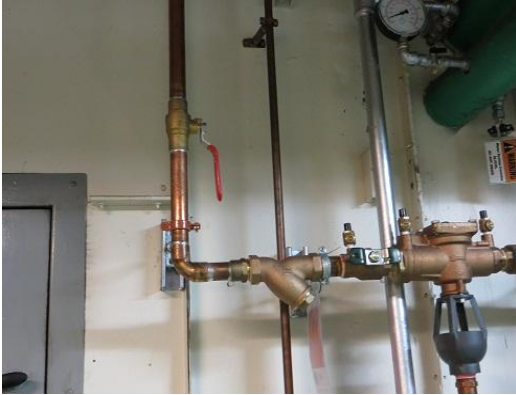
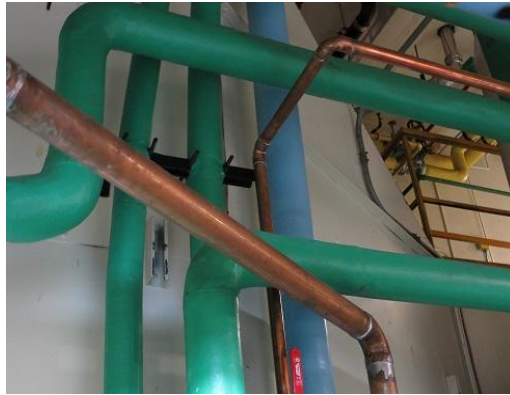
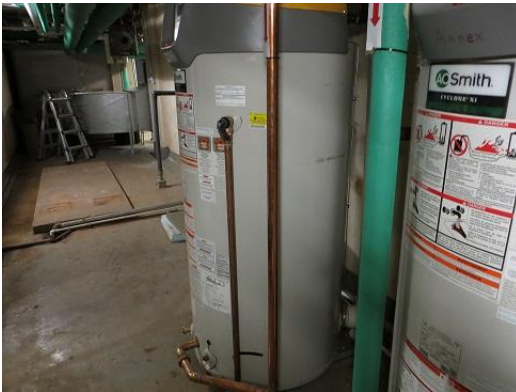
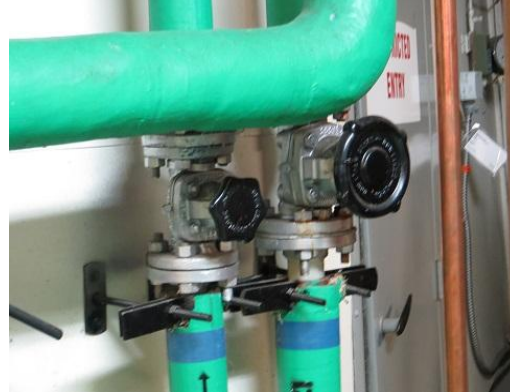
Upper Mechanical Room

The insulation materials applied to the piping in the 9th floor mechanical room are quite minimal. This room has all but been de-commissioned and there were few items to mention. However, there is a minor amount of domestic piping which has been repaired or replaced and is missing insulation.

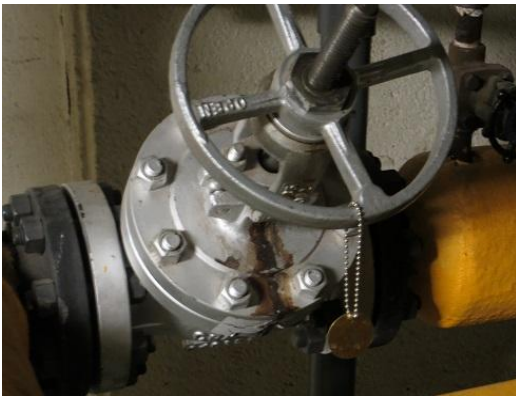
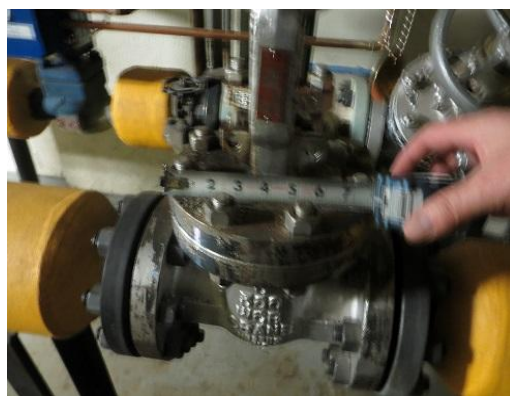
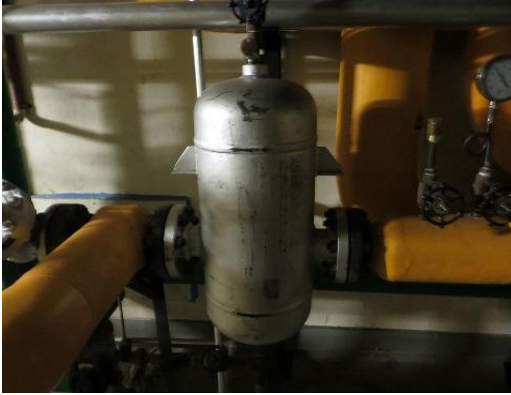
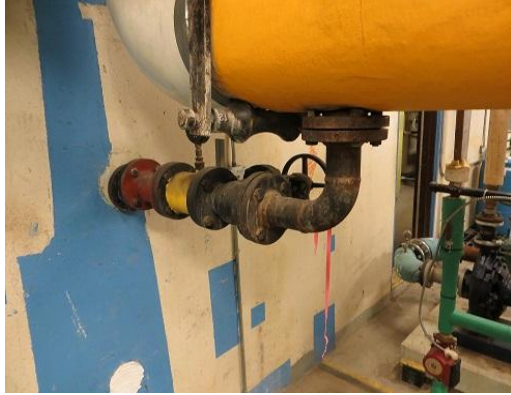
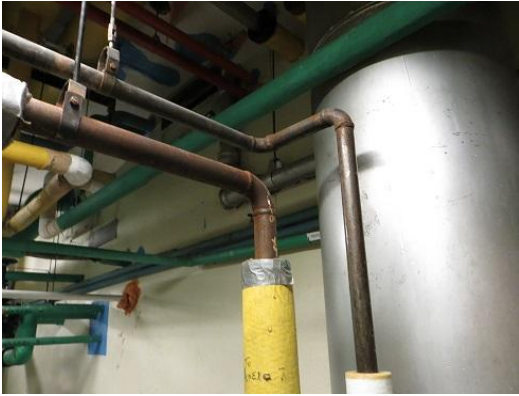
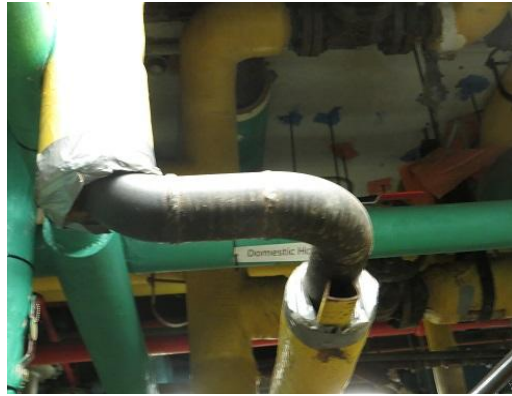
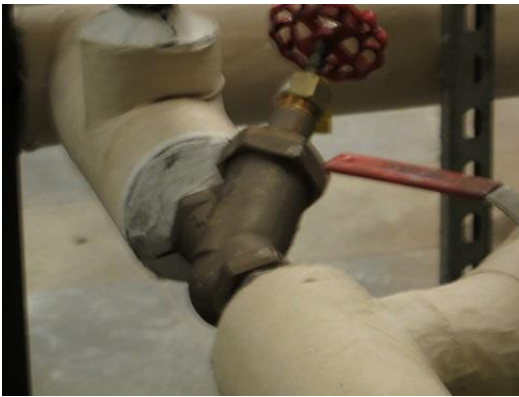
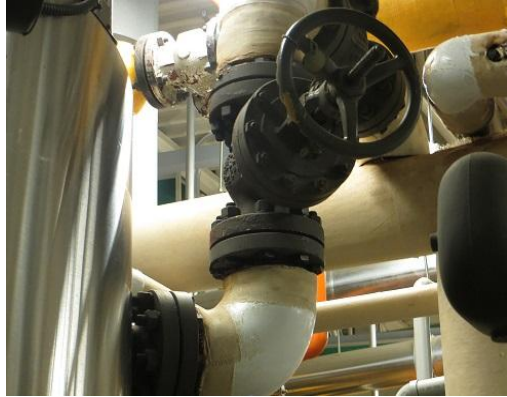
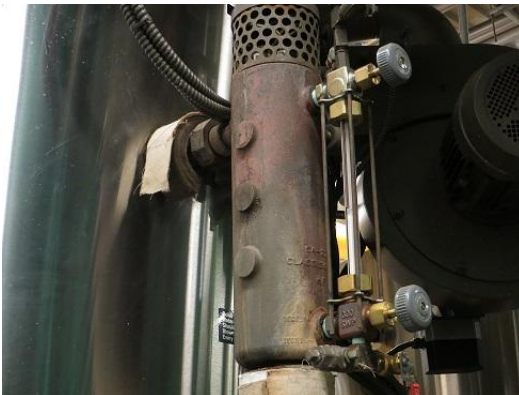
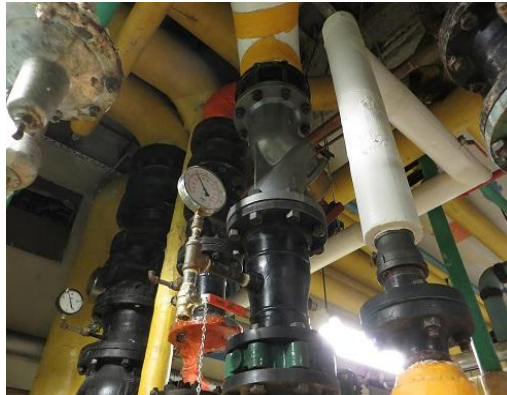
Personnel Protection

We also would like to address the hazards that the hot exposed items present to personnel. The boiler rooms and fan rooms generally are tightly packed with equipment and piping systems operating up to 121°C, the systems and equipment which are not insulated leave many opportunities for employees and maintenance personnel to come in contact with these surfaces which can burn skin. Properly insulated systems and equipment eliminate the possibility of individuals coming into contact with these hot surfaces and will prevent accidental burns which will add value by individuals not having claims and or lost time incidents.
