SALAMANDER INSPECTIONS LTD
Mechanical Insulation Energy Audits

Energy Audit

Victoria General Hospital

Laundry Services

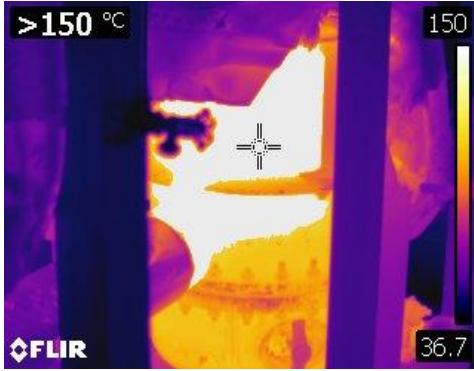
Figure 3 This thermographic image of the bottom of Steam Pac 1 at 150° C or 302° F.

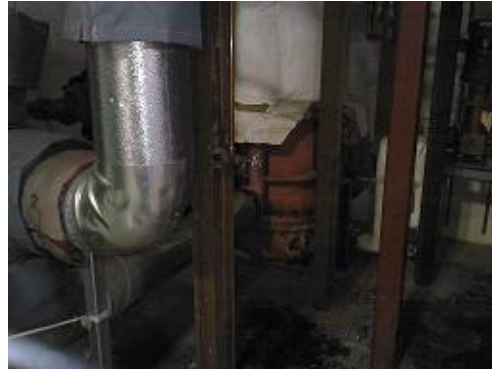
Figure 4 This is a conventional photo of the same bottom section of Steam Pac 1.

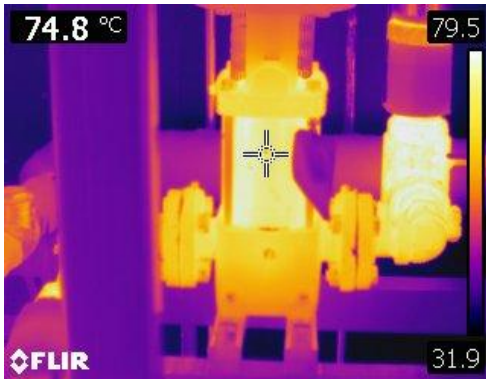
Figure 5 This thermographic image is of a pump located adjacent to Steam Pac 1. Also associated piping is not insulated at 74° C or 154° F

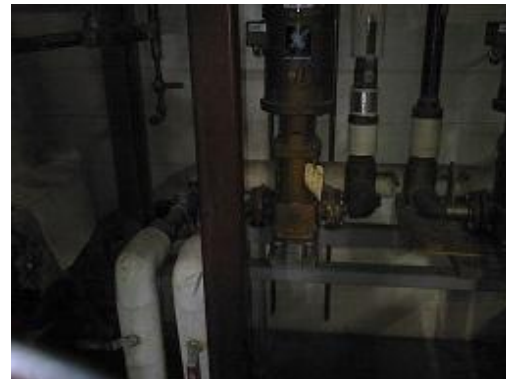
Figure 6 This conventional photo shows the same piping.

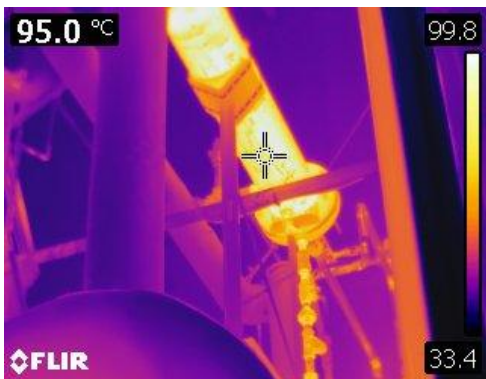
Figure 7 This thermographic image of a heat exchanger above Steam Pac 1 at 95° C or 203° F.

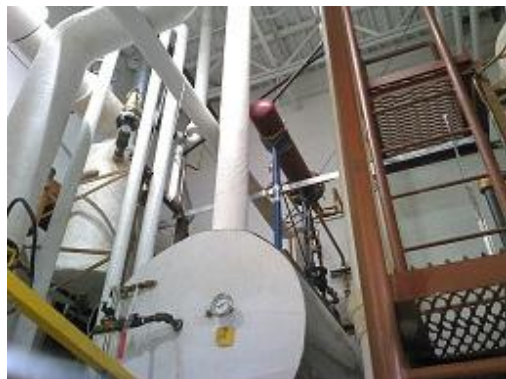
Figure 8 This is a conventional photo of the heat exchanger.

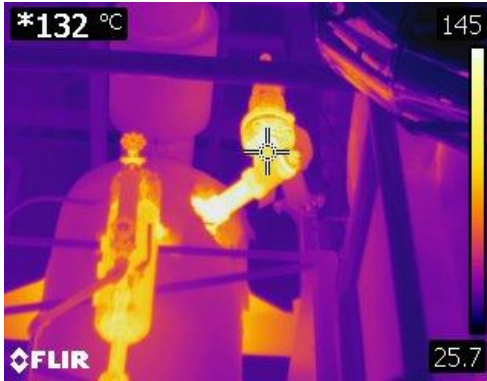
Figure 9 This thermographic image is of the sight glass and blow off/piping from this vessel at 132° C or 289° F.

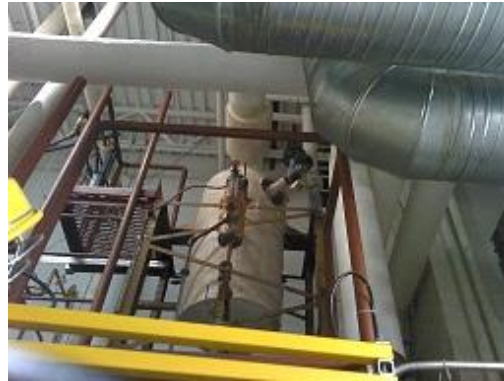
Figure 10 This is a conventional photo of the same sight glass and blow off/piping.

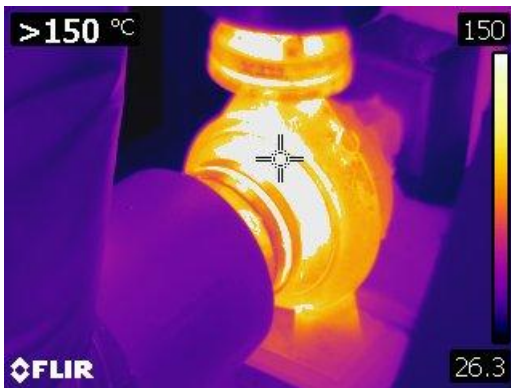
Figure 11 This thermo graphic image is of a motorized circulation pump at 150° C or 302° F.

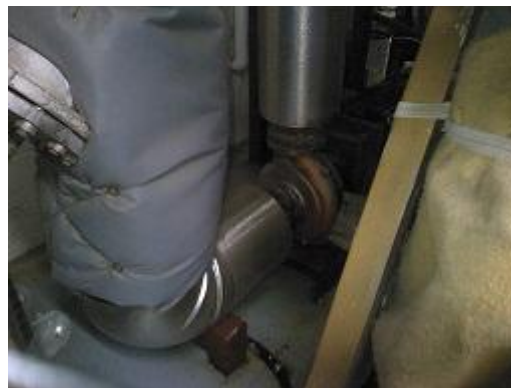
Figure 12 This is the conventional image of the same motorized pump.

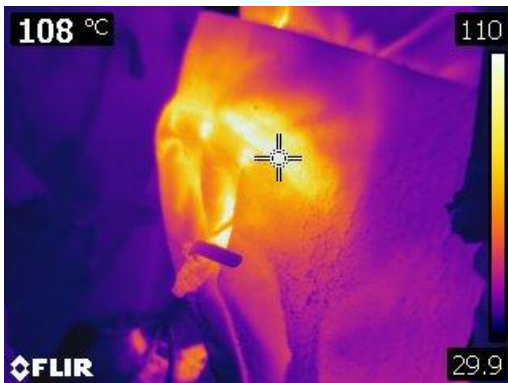
Figure 13 This thermographic image is of a heating supply strainer covered with cloth at 108° C or 226° F. this item is above 65C which is over the personal protective limit.

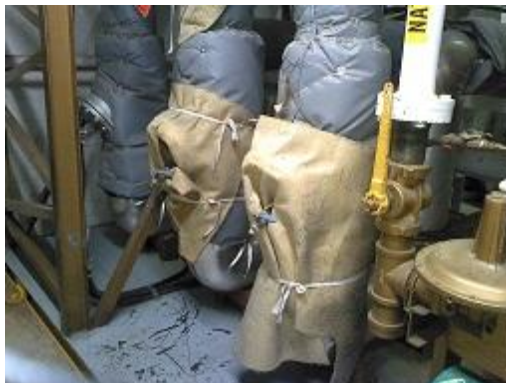
Figure 14 This is a conventional image of the same strainers covered by cloth.

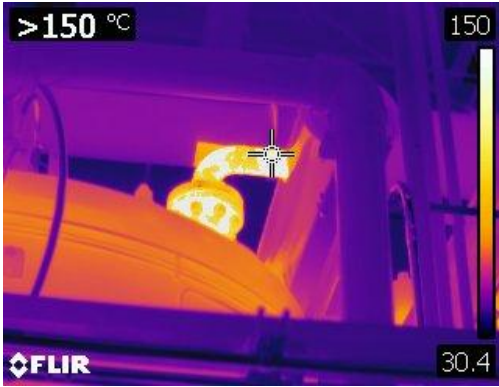
Figure 15 This thermographic image is of supply piping at top of boiler at 150° C or 302° F.

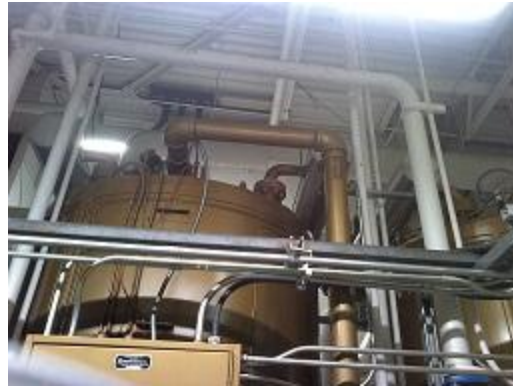
Figure 16 This is a conventional image of the same pipe at the top of the boiler.

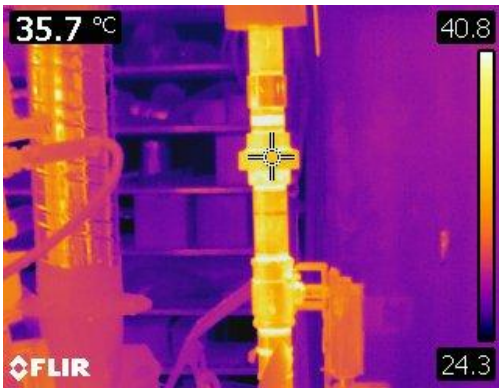
Figure 17 This thermographic image is of a pipe to motorized pump at 35° C or 95° F.

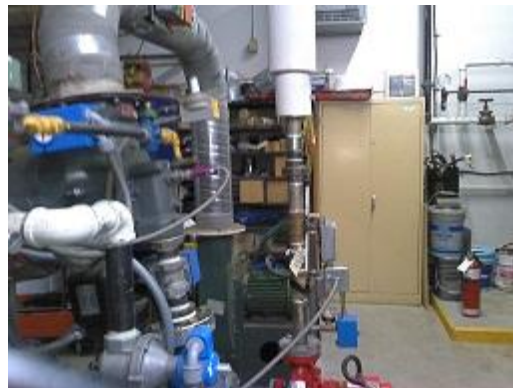
Figure 18 This conventional image is of the same pipe to the motorized pump.

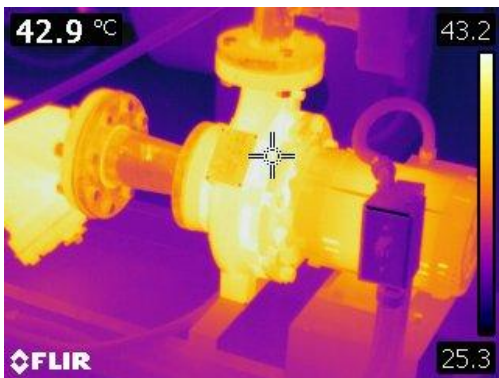
Figure 19 Thermographic image of a motorized pump and pipe at 42° C or 107° F.

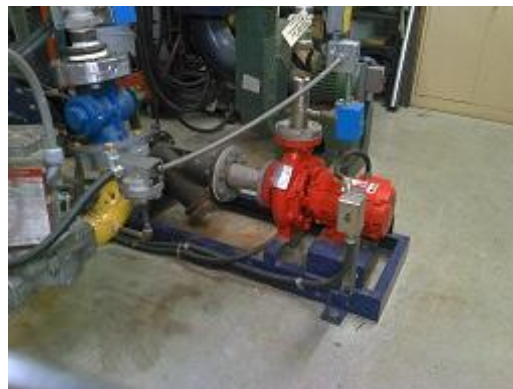
Figure 20 conventional image of the same pump and piping.

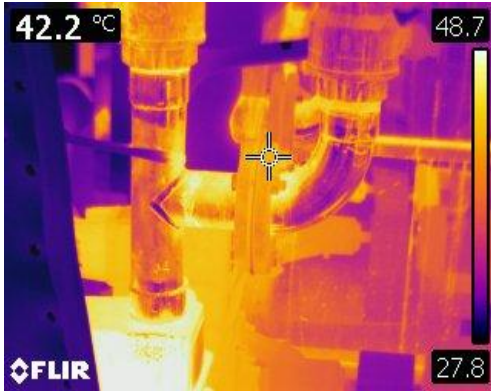
Figure 21 Thermographic image of bare piping and valves at 42° C or 107° F.

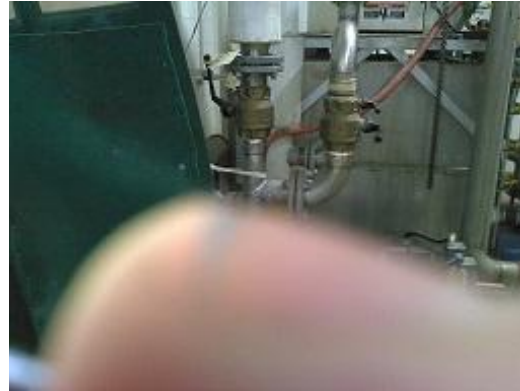
Figure 22 Conventional image of the same piping and valves.

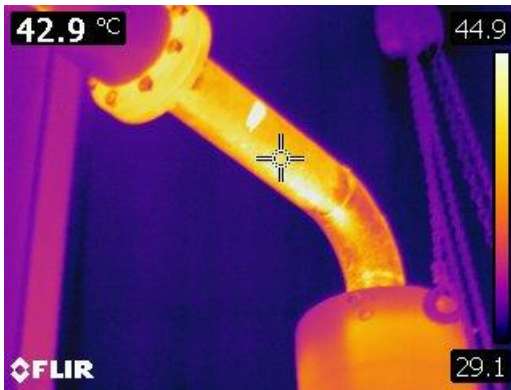
Figure 23 Thermographic image of bare piping and flange at 42° C or 107° F.

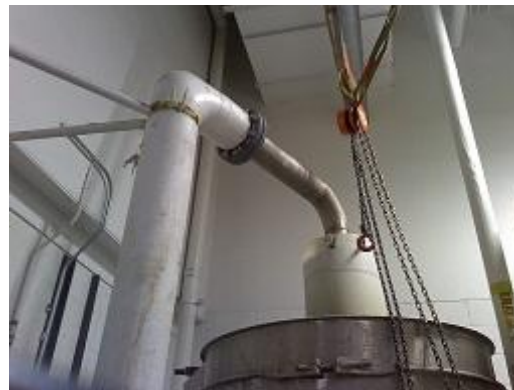
Figure 24 Conventional image of the same piping and flange.

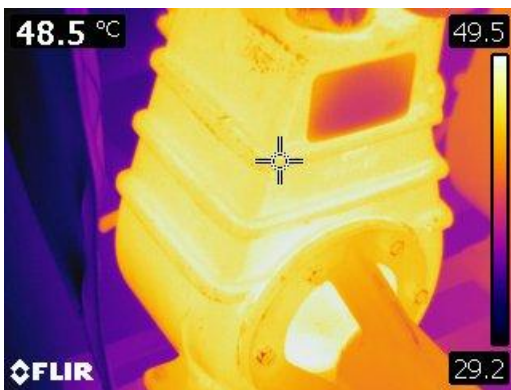
Figure 25 Thermographic image of bare pump and flange at 48° C or 118° F.

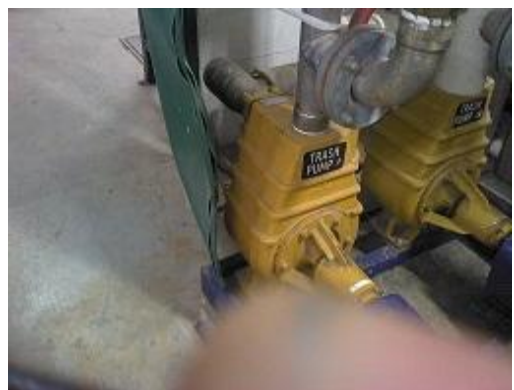
Figure 26 Conventional image of the same pump and flange.

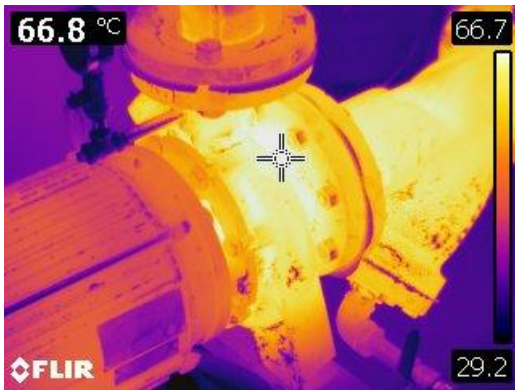
Figure 27 Thermographic image of bare pump and flange at 66° C or 150° F.

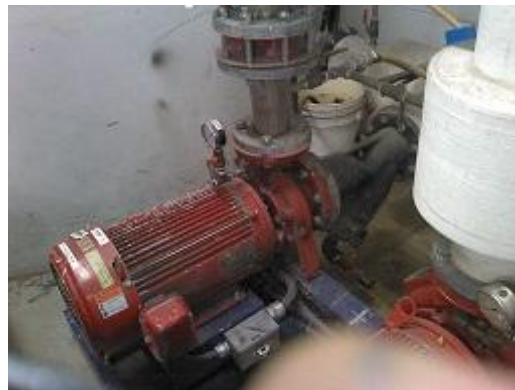
Figure 28 Conventional image of the same pump and flange.

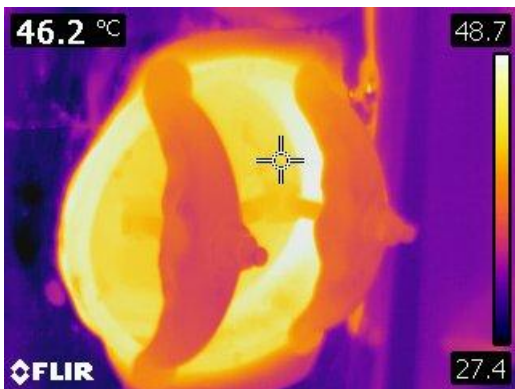
Figure 29 Thermographic image of the access hatch on vessel at 46° C or 114° F.

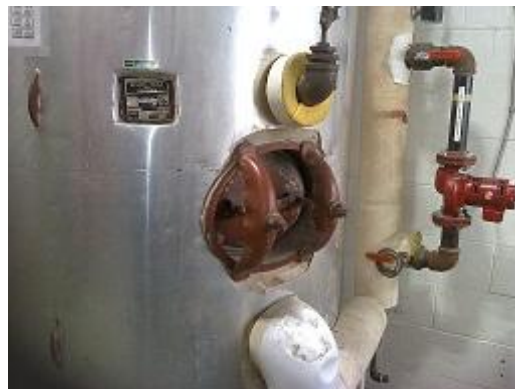
Figure 30 Conventional image of the same access hatch and piping.

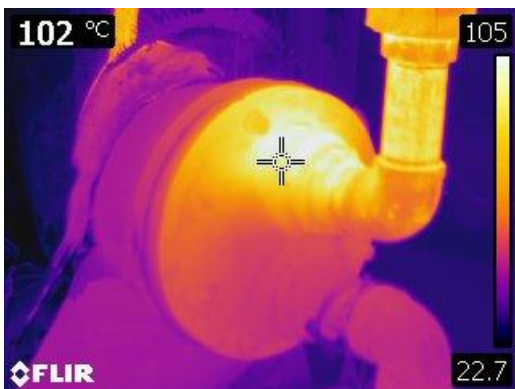
Figure 31 Thermographic image of a heat exchanger in vessel at 102° C or 215° F.

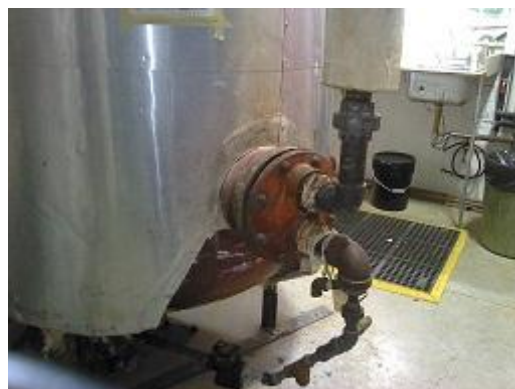
Figure 32 Conventional image of the same heat exchanger and piping.

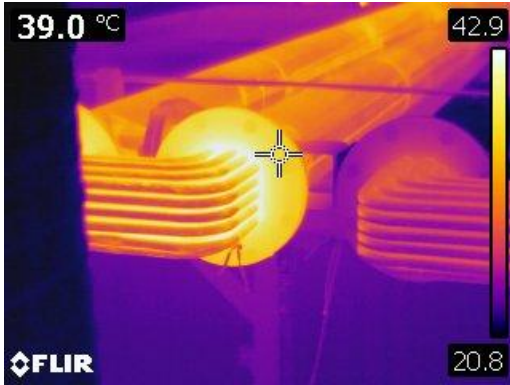
Figure 33 Thermographic image of heat recovery piping at 39° C or 102° F.

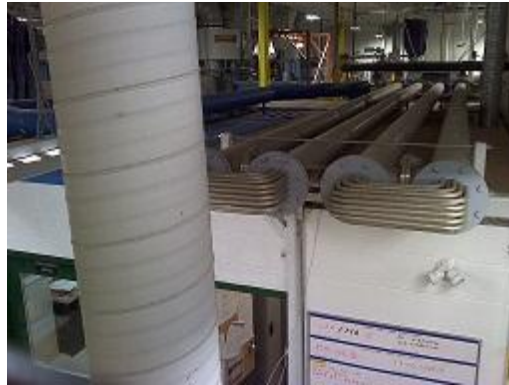
Figure 34 Conventional image of the same heat recovery piping.

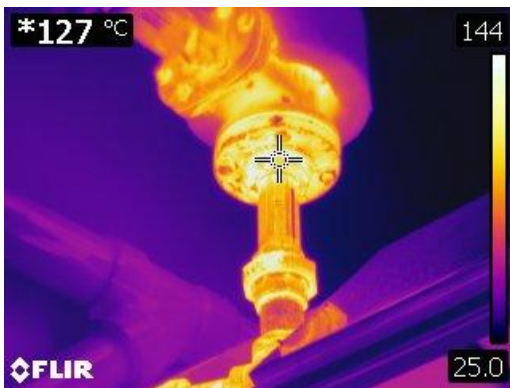
Figure 35 Thermographic image of steam supply to washers at 127° C or 260° F.

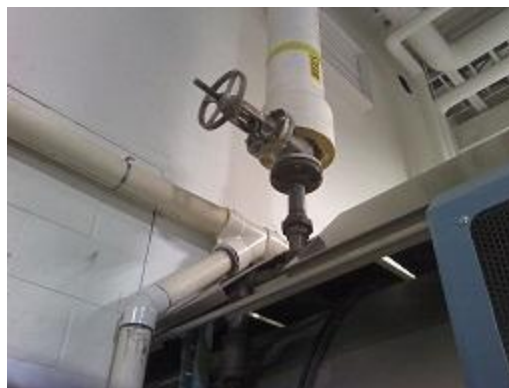
Figure 36 Conventional image of the same steam supply piping.

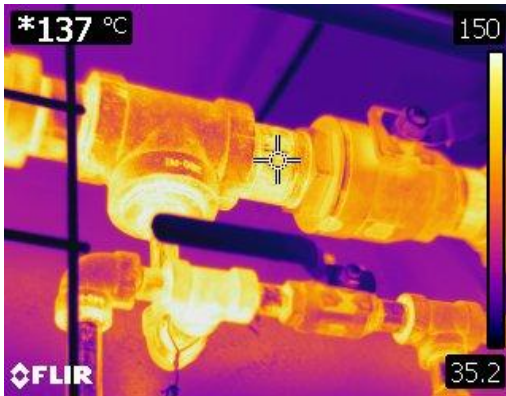
Figure 37 Thermographic image of a steam supply line to washers at 137° C or 278° F.

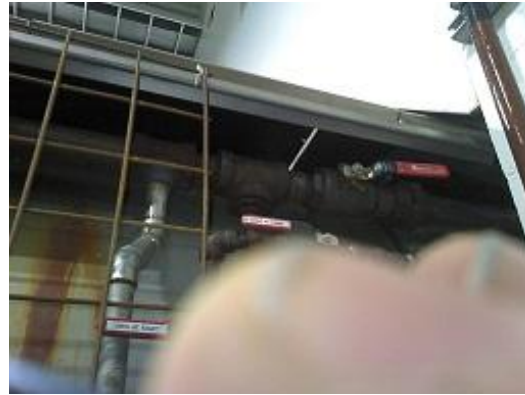
Figure 38 Conventional image of the same steam supply piping.

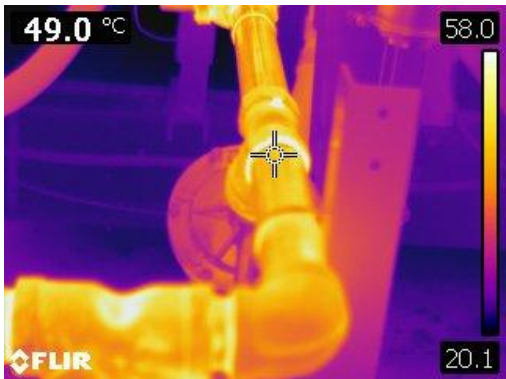
Figure 39 Thermographic image of a supply line at the bottom of the washers at 137° C or 278° F.

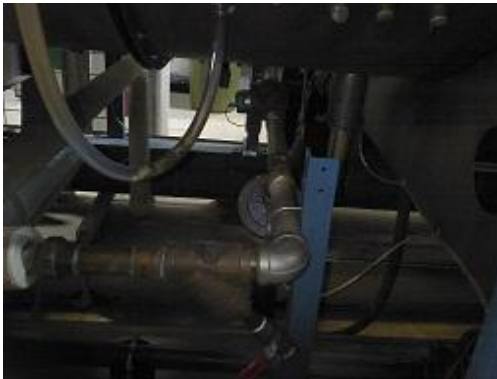
Figure 40 Conventional image of the supply line at the bottom of the washers.
