Salamander Inspections Ltd.
Mechanical Insulation Energy Audits

Energy Audit

Wascana Powerhouse

2405 Legislative Dr. Avenue C

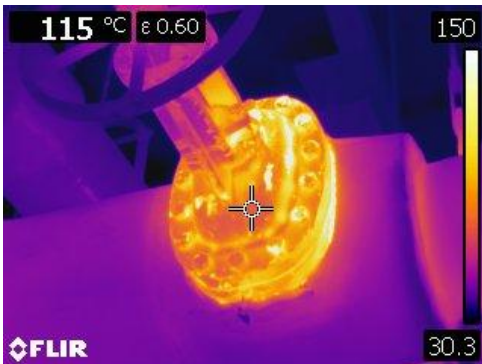
Figure 3 This is a thermographic image of an exposed valve bonnet at 115° C, or 239° F.

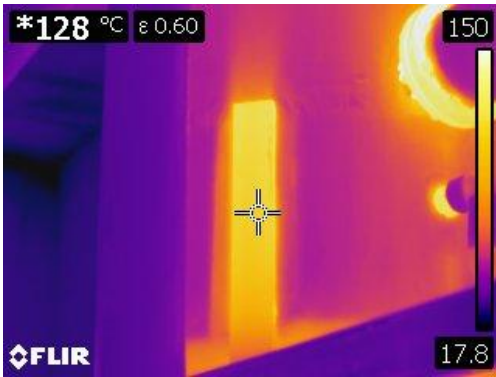
Figure 19 Thermographic image of the bare vessel support at 128° C or 262° F

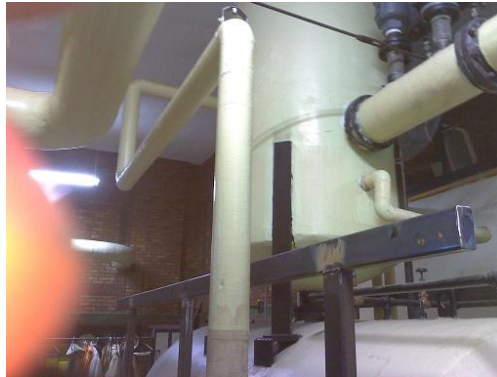
Figure 20 Conventional image of the same support.

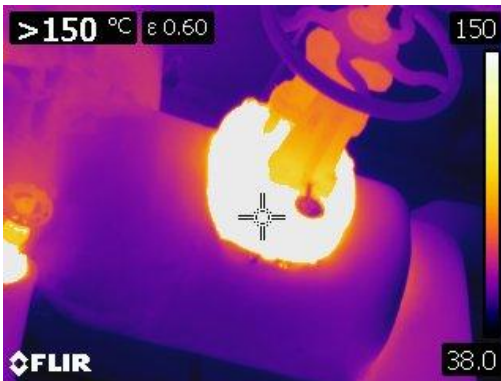
Figure 25 Thermographic image of a valve bonnet at a temperature greater than 150° C or >302° F.

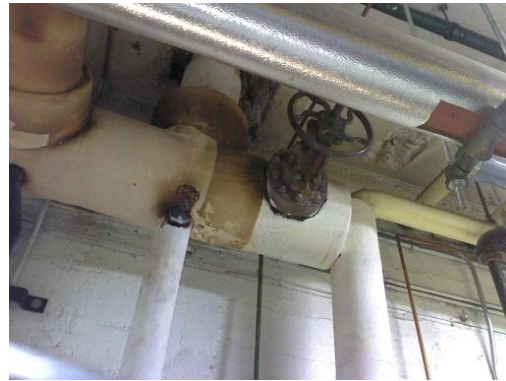
Figure 26 conventional image of the same valve bonnet. Note the burnt pipe covering.

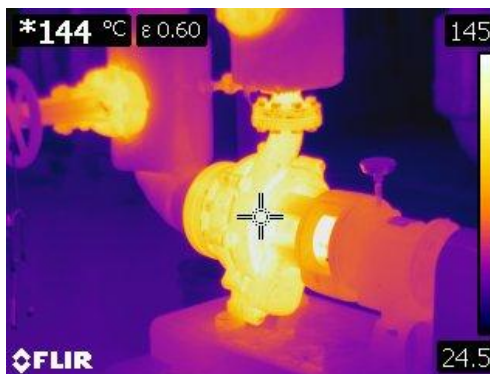
Figure 27 Thermographic image of pump at 144° C or 291° F.

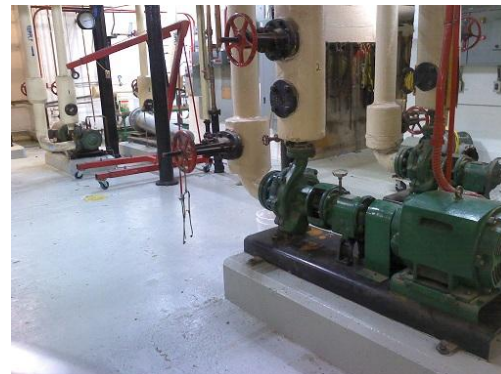
Figure 28 Conventional image of the same pump.

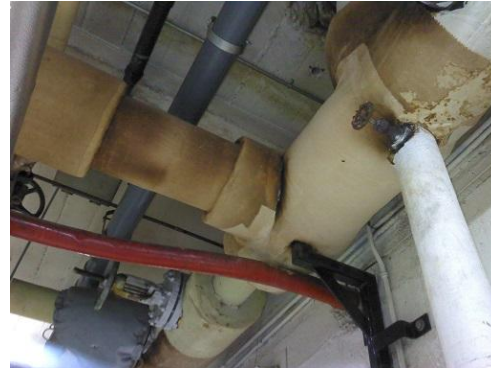
Figure 36 Conventional image of the same insulated piping. Note how the canvas is burned due to the heat.

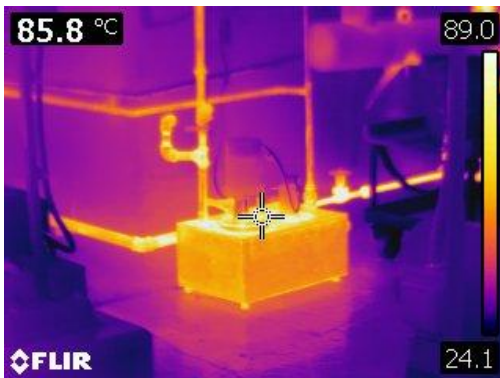
Figure 37 Thermographic image of a box at 85.8° C or 186° F.

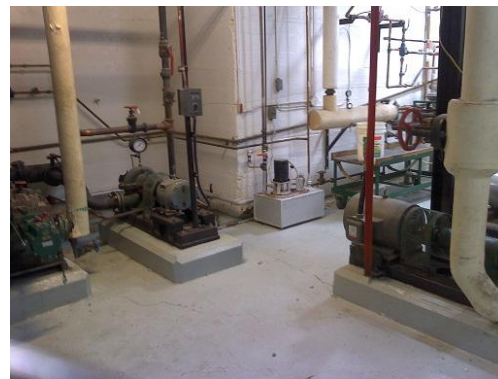
Figure 38 Conventional image of the same box. Note the uninsulated copper lines in the same area.

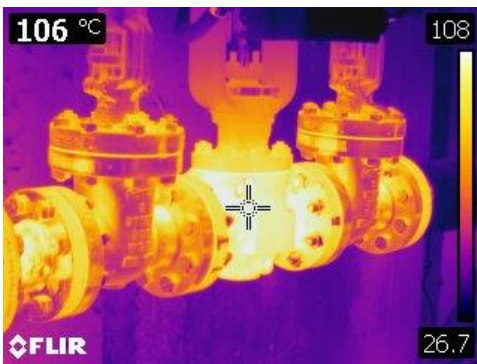
Figure 41 Thermographic image of bare valves at a temperature of 106° C or 223° F.

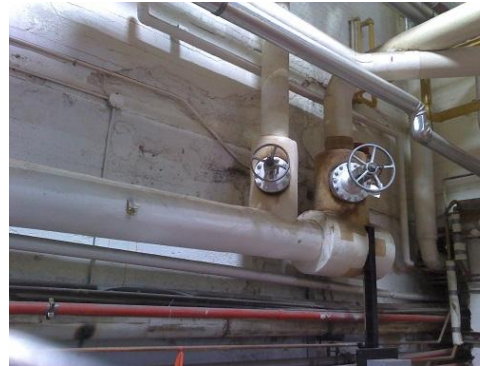
Figure 48 Conventional image of bare valve bonnets. Note the canvas is burnt due to exposure to high temperatures.

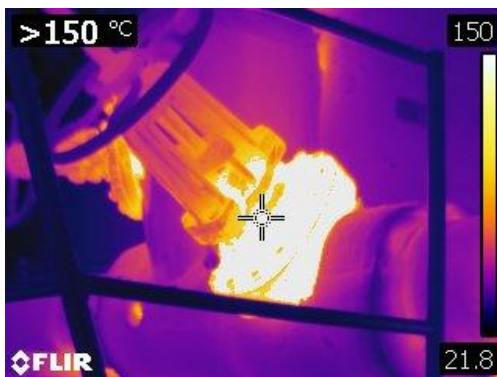
Figure 49 Thermographic image of bare valve bonnets and a pressure reducing valve at 119° C or 246° F

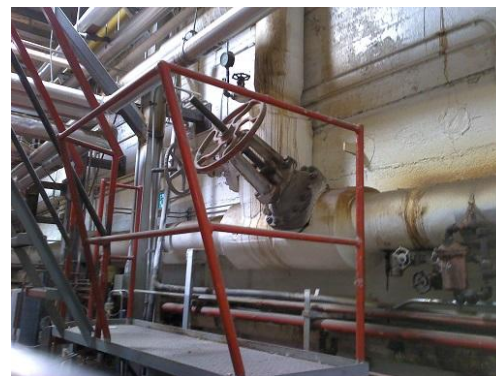
Figure 50 Conventional image of valve bonnets.

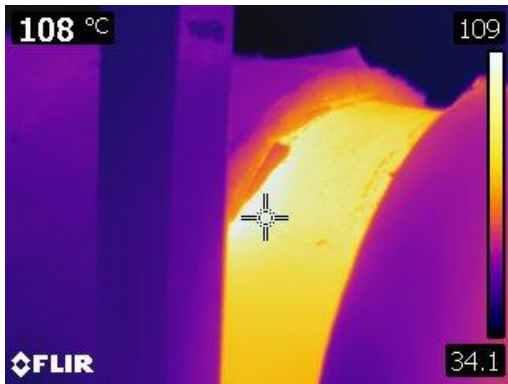
Figure 55 Thermographic image of a bare pipe shoe at 108 °C or 226° F

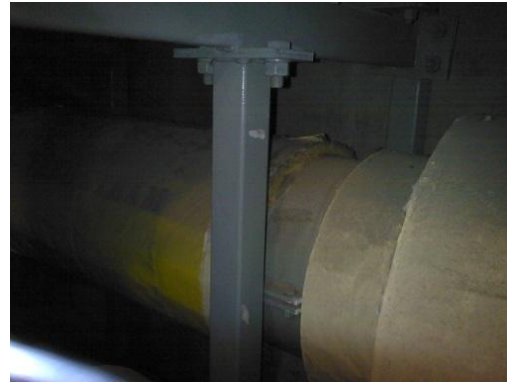
Figure 56 Conventional image of the same shoe.

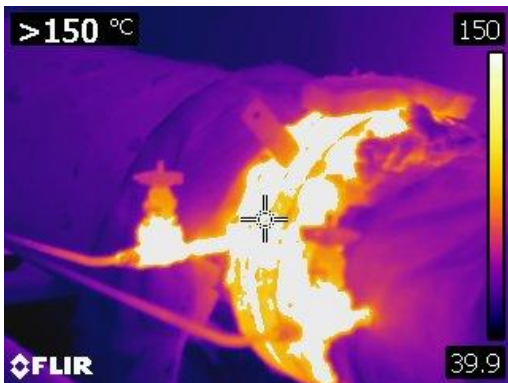
Figure 57 Thermographic image of bare flange and small valve greater than 150° C or 302° F

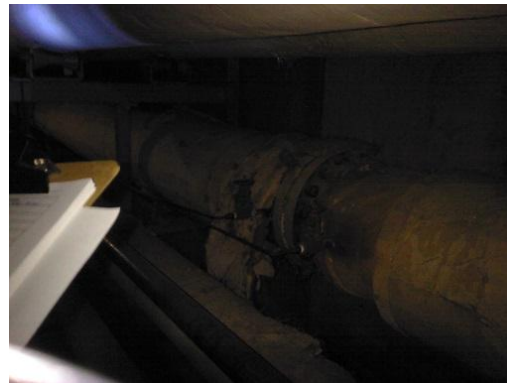
Figure 58 Conventional image of the same flange and valve.

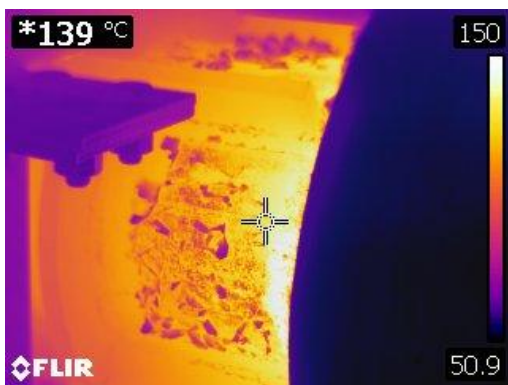
Figure 59 Thermographic image of bare pipe rack support at 139° C or 282° F

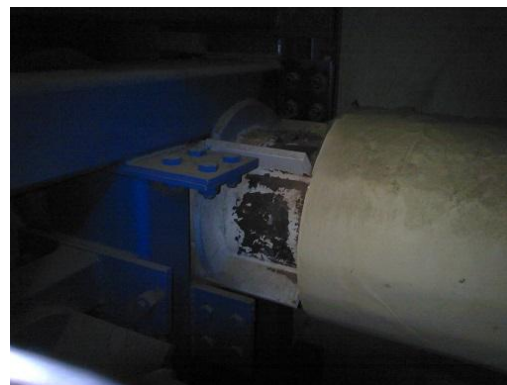
Figure 60 Conventional image of the same pipe rack support.

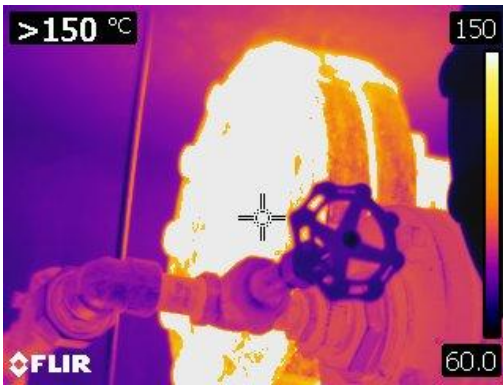
Figure 61 Thermographic image of bare flange greater than 150° C or 302° F

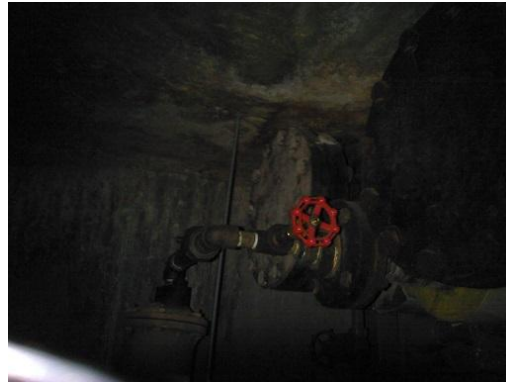
Figure 62 Conventional image of the same flange.

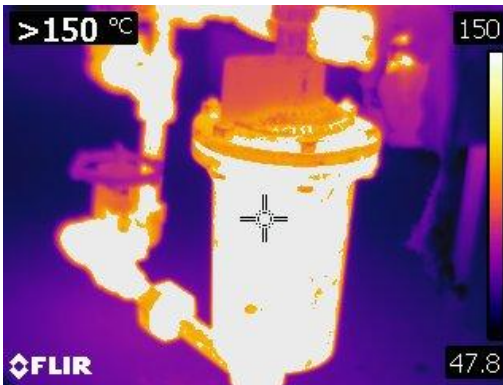
Figure 63 Thermographic image of bare steam trap greater than 150° C or 302° F.

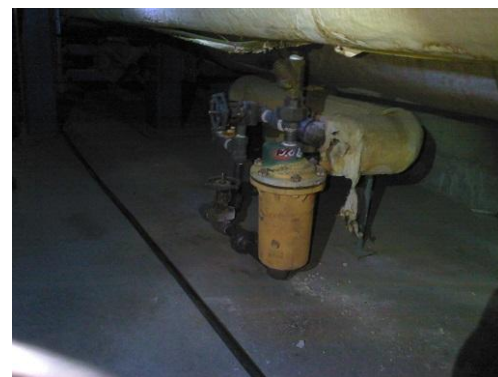
Figure 64 Conventional image of the same steam trap.

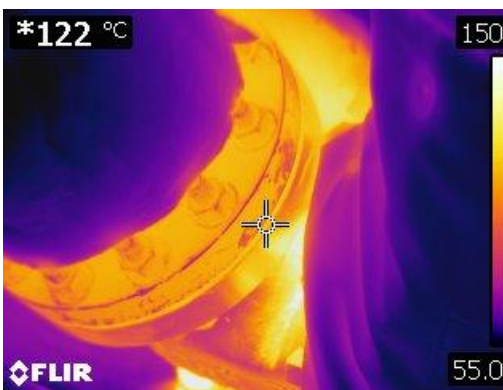
Figure 65 Thermographic image of bare valve at 122° C or 252° F.

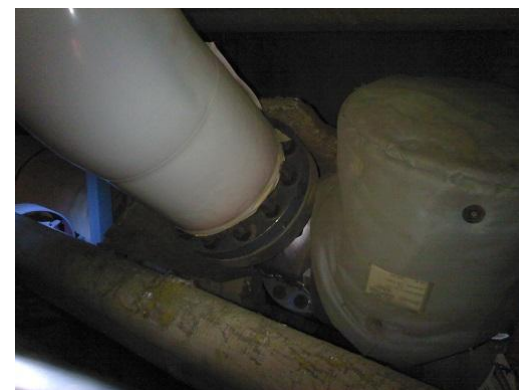
Figure 66 Conventional image of the same valve.

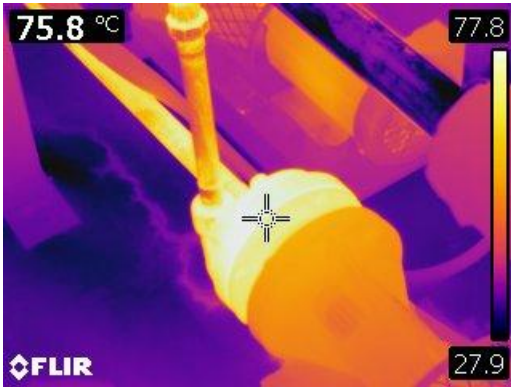
Figure 67 Thermographic image of bare pipe and flanges at 75.8° C or 168° F

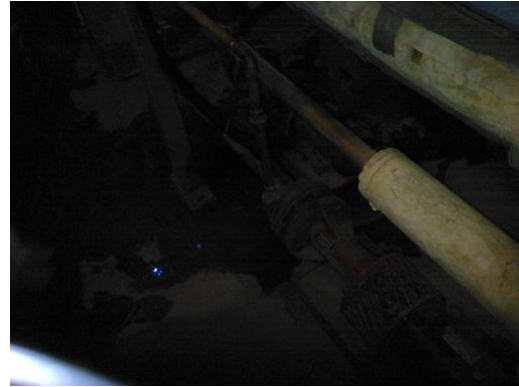
Figure 68 Conventional image of the same piping and flanges.

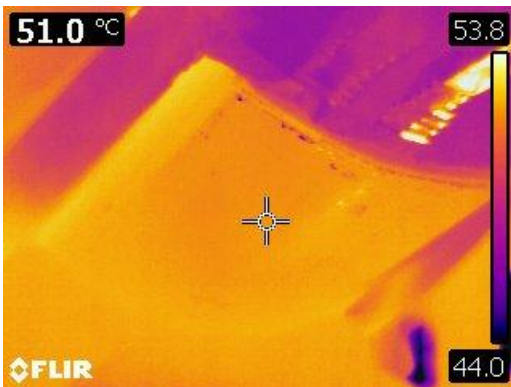
Figure 69 Thermographic image of a bare roller support at 51° C or 124° F

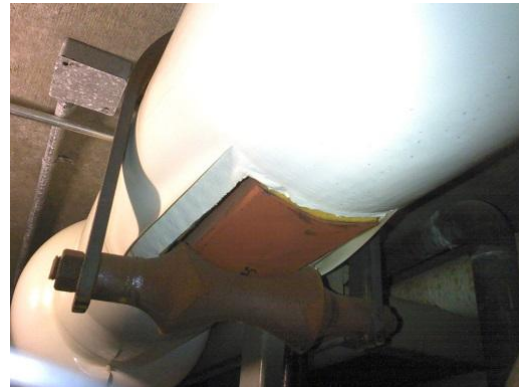
Figure 70 Conventional image of the same roller support.

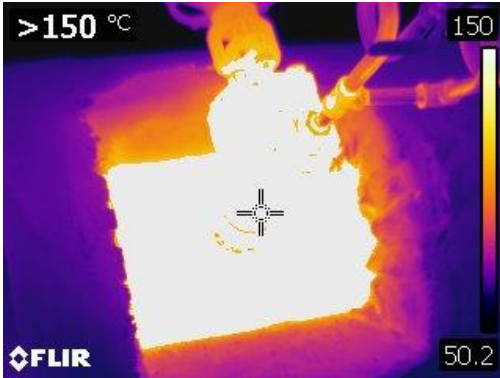
Figure 71 Thermographic image of a bare section of pipe and valve greater than 150° C or 302° F

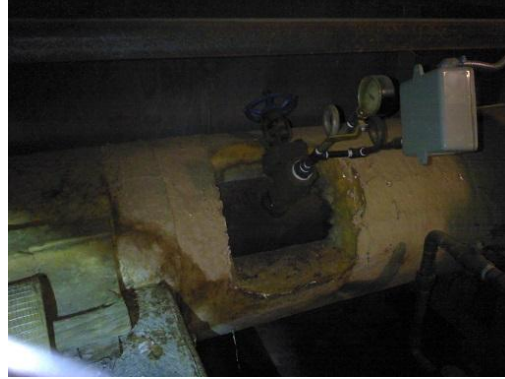
Figure 72 Conventional image of the same pipe and valve.

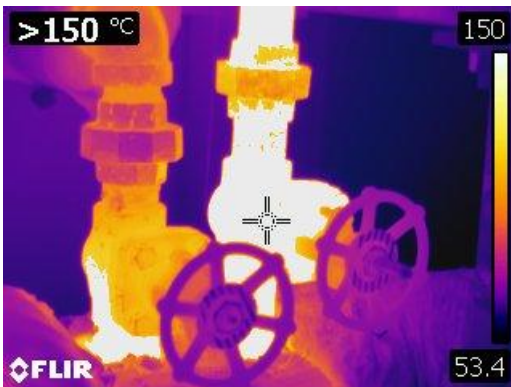
Figure 73 Thermographic image of uninsulated valves greater than 150° C or 302° F

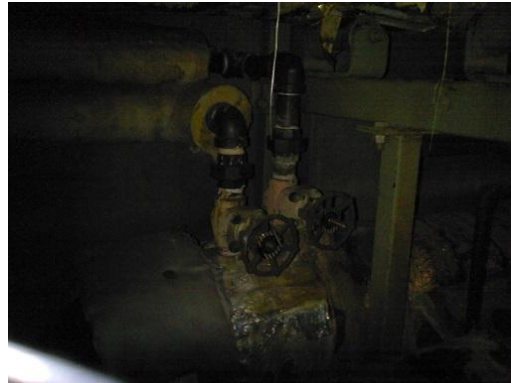
Figure 74 Conventional image of the same valves.

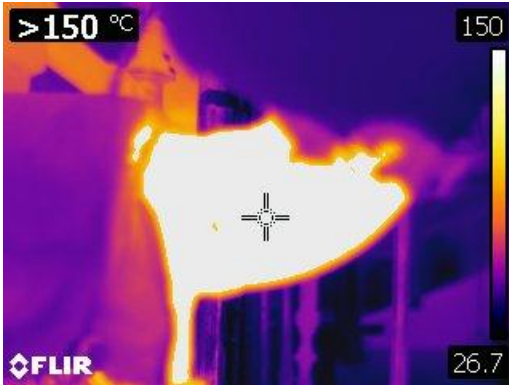
Figure 75 Thermographic image of an uninsulated elbow greater than 150° C or 302° F.

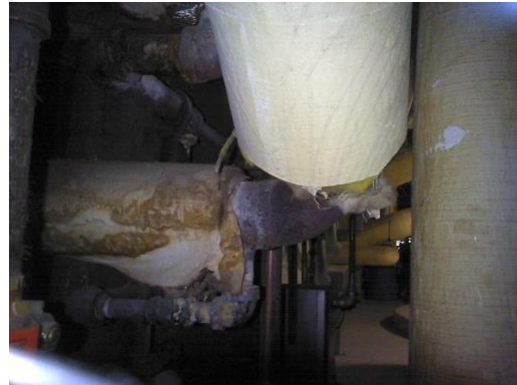
Figure 76 Conventional image of the same elbow.

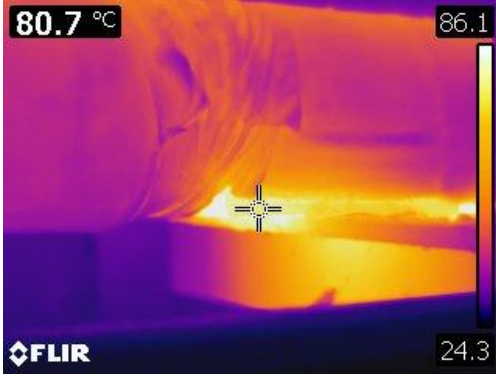
Figure 81 Thermographic image of an improperly insulated pipe shoe at 80.7° C or 177° F

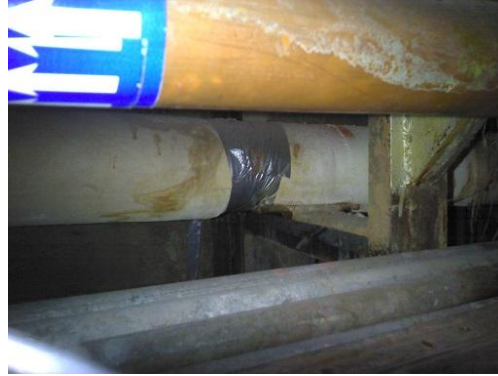
Figure 82 Conventional image of the same shoe.

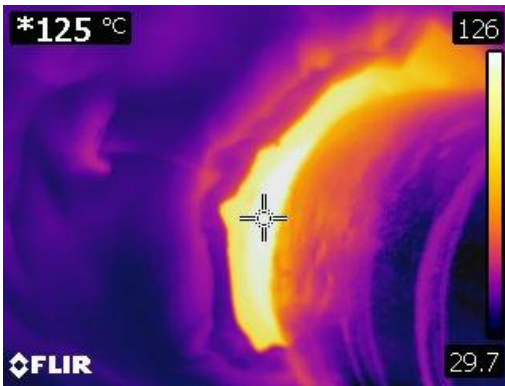
Figure 83 Thermographic image of an improperly insulated heat exchanger at 125° C or 257° F

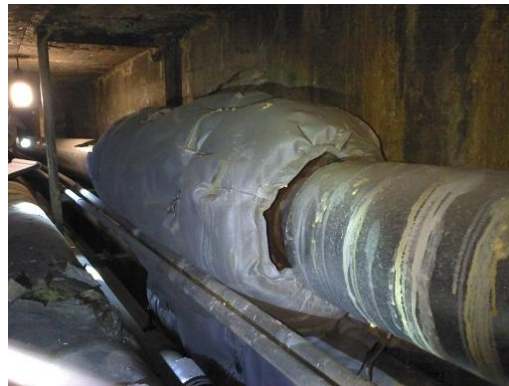
Figure 84 Conventional image of the same exchanger.

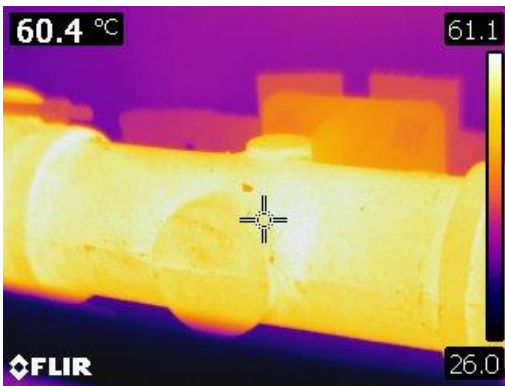
Figure 85 Thermographic image of a bare heat exchanger at 60.4° C or 141° F

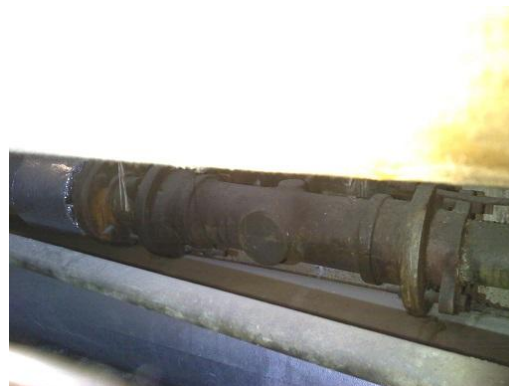
Figure 86 Conventional image of the same exchanger.

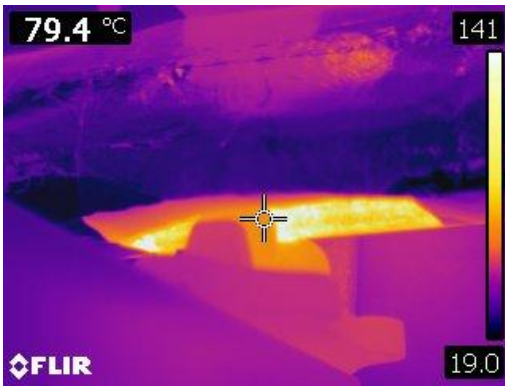
Figure 87 Thermographic image of an uninsulated roller support at 79.4° C or 175° F

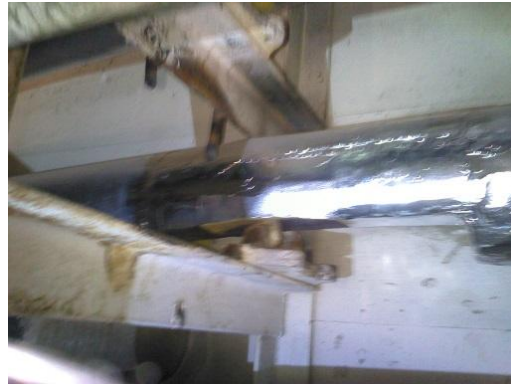
Figure 88 Conventional image of the roller support.

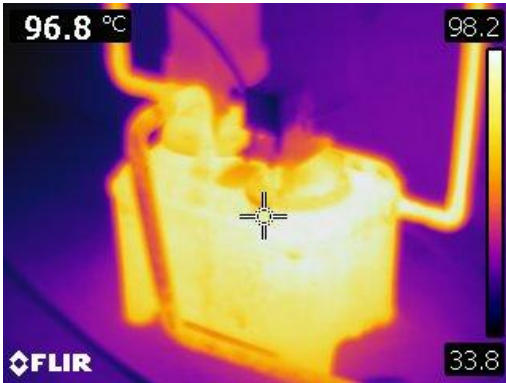
Figure 89 Thermographic image of an uninsulated sump pump at 96.8° C or 206° F

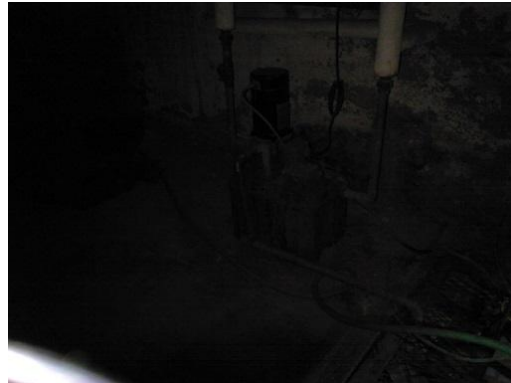
Figure 90 Conventional image of the same sump pump.

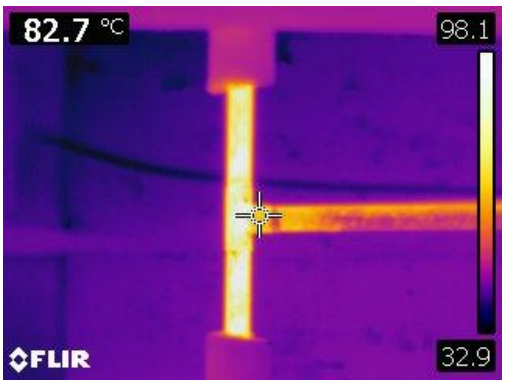
Figure 91 Thermographic image of bare piping at 82.7° C or 181° F

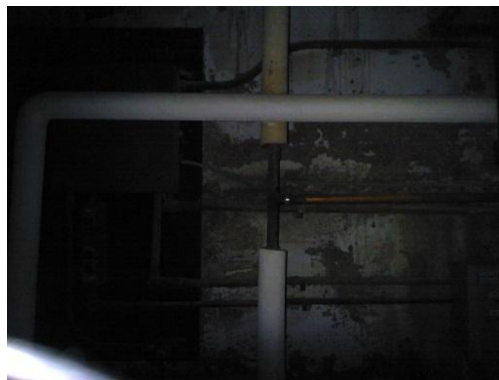
Figure 92 Conventional image of the same bare piping.

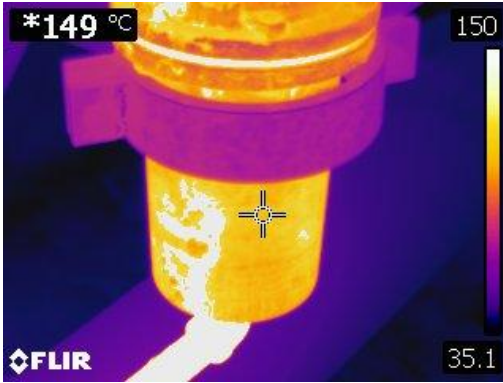
Figure 93 Thermographic image of an uninsulated steam trap at 149° C or 300° F

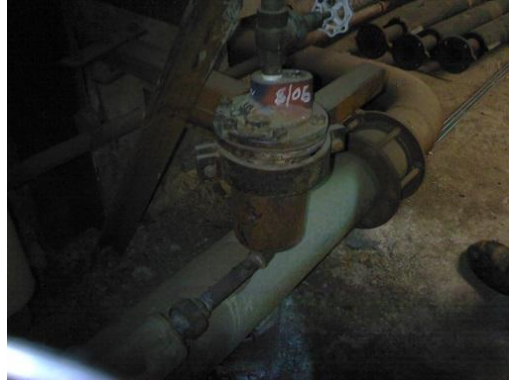
Figure 94 Conventional image of the same steam trap.

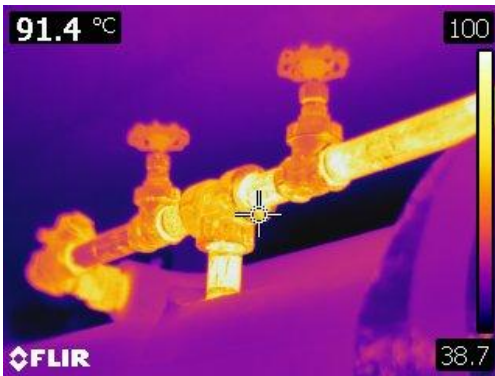
Figure 95 Thermographic image of bare piping and valves at 91.4° C or 197° F

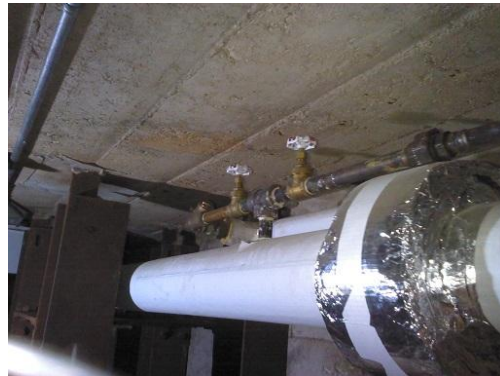
Figure 96 Conventional image of the same piping and valves.

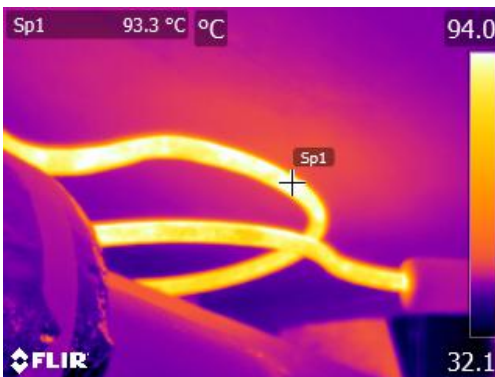
Figure 97 Thermographic image of uninsulated piping at 93.3° C or 200° F

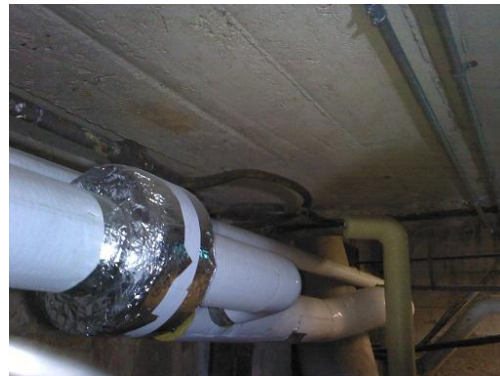
Figure 98 Conventional image of the same piping.

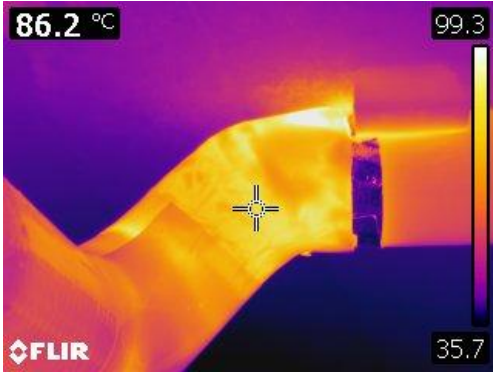
Figure 99 Thermographic image of improperly insulated piping where the outside surface temperature is 86.2° C or 187° F

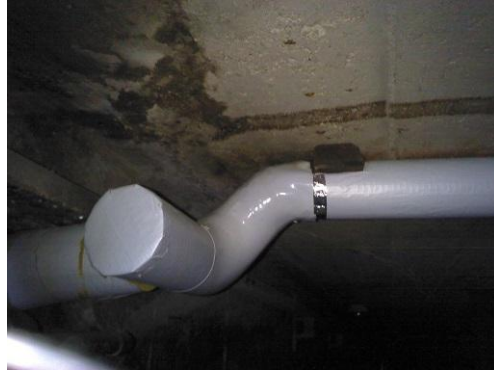
Figure 100 Conventional image of the same piping, note that the PVC jacketing on the material is melting.

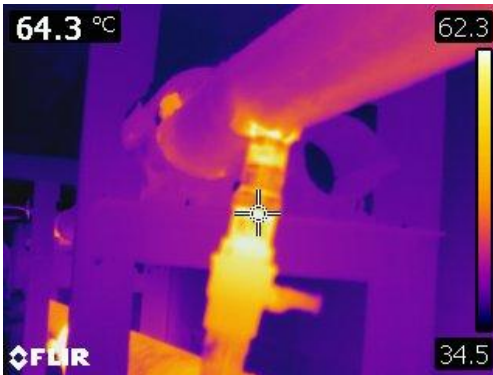
Figure 101 Thermographic image a bare valve at 64.3° C or 148° F

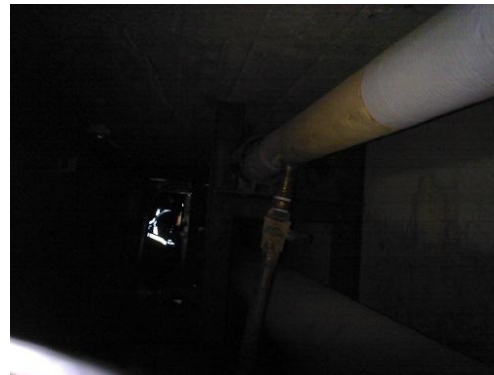
Figure 102 Conventional image of the same valve.

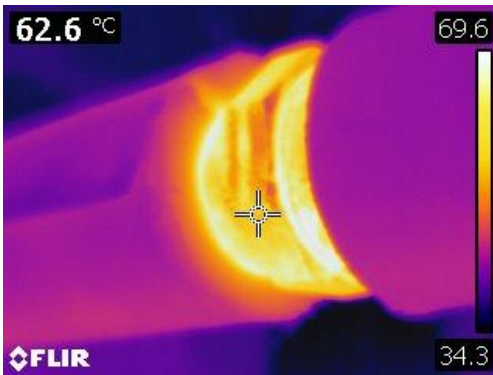
Figure 103 Thermographic image of a bare piping union at 62.6° C or 145° F

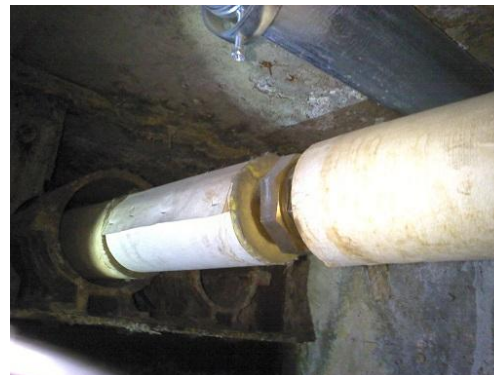
Figure 104 Conventional image of the same union.

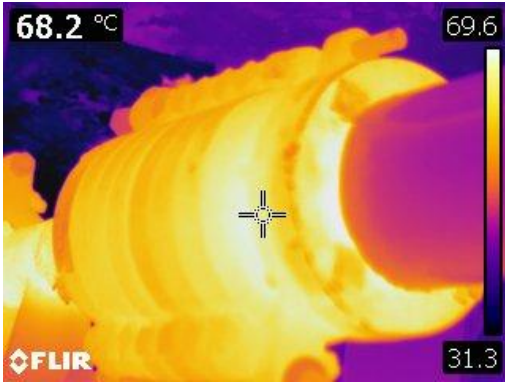
Figure 105 Thermographic image of an uninsulated expansion joint at 68.2° C or 155° F

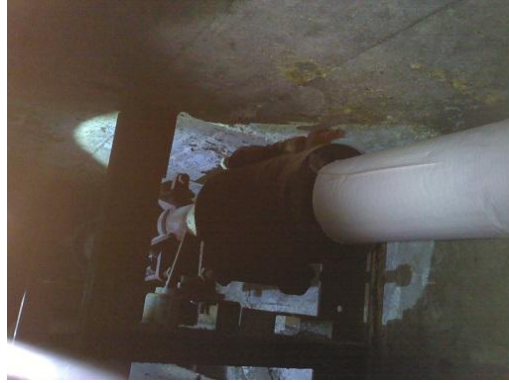
Figure 106 Conventional image of the same expansion joint.

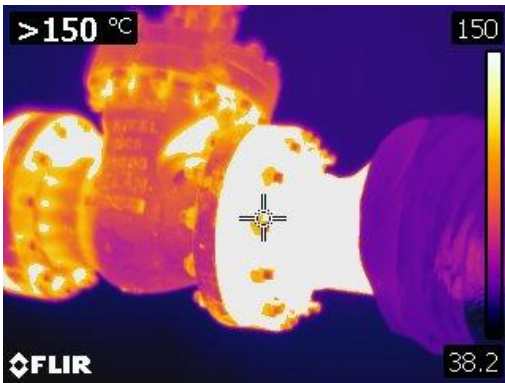
Figure 107 Thermographic image of an uninsulated valve at a temperature greater than 150° C or 302° F

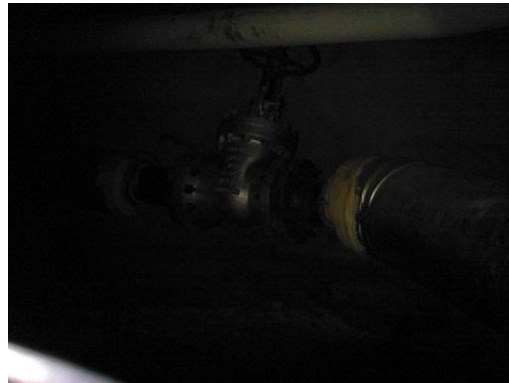
Figure 108 Conventional image of the same valve.

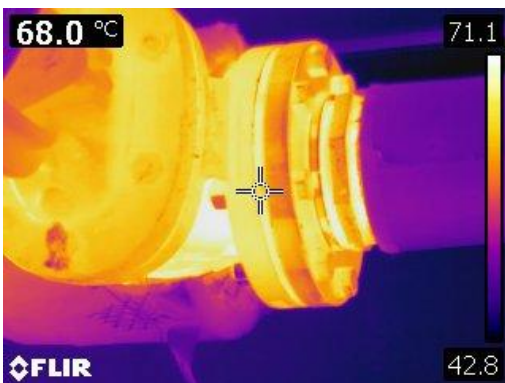
Figure 109 Thermographic image of an uninsulated valve at 68° C or 154° F

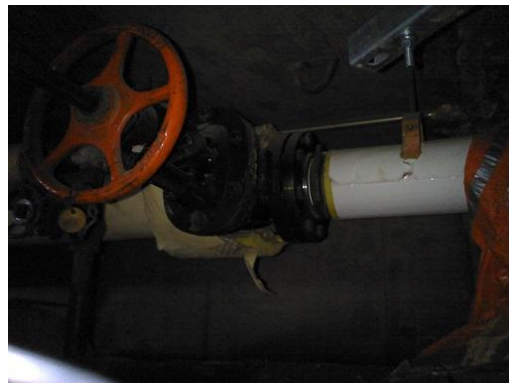
Figure 110 Conventional image of the valve.

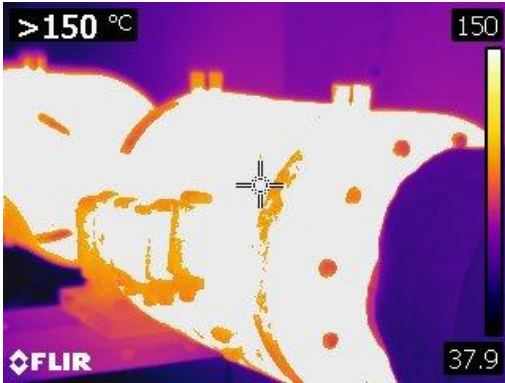
Figure 111 Thermographic image of an uninsulated expansion joint greater than 150° C or 302° F

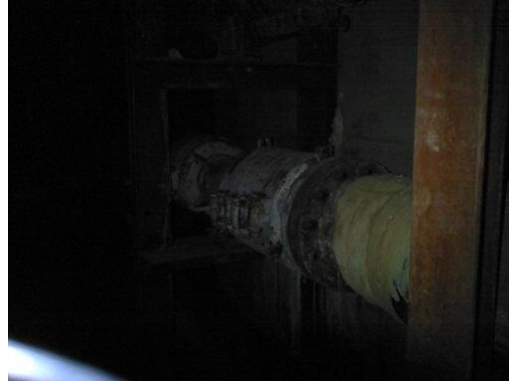
Figure 112 Conventional image of the same expansion joint.
