SALAMANDER INSPECTIONS LTD
Mechanical Insulation Energy Audits

Energy Audit

April 6, 2016

The OS Longman Laboratory Building is located at 6909 – 116 Street, Edmonton Alberta. This building comprises governmental testing services.

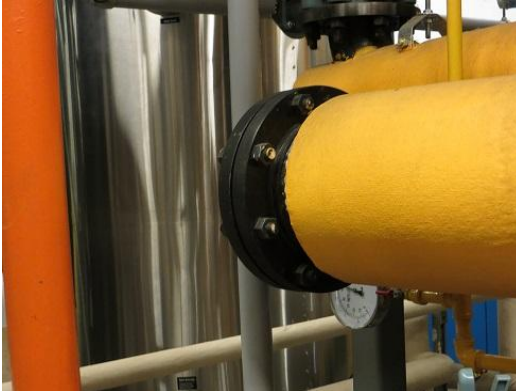
Looking at the work done in the boiler room there appears to be two different contractors doing the work. There are areas of mechanical around the steam boilers that are not finished properly. The temperature of the lines coming off the boilers approach 148C, if you look closely at the pictures you can see burnt canvas and melted PVC elbows from lack of insulation underneath.

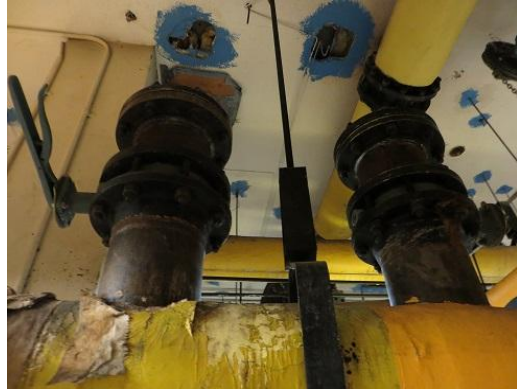
We have walked through and inspected the mechanical room on the second floor and found numerous areas which will require insulation to be applied to achieve thermal efficiency. The overall workmanship is good but as seen in other areas insulation has not been applied to any valves, strainers, pumps or heat exchangers. There are areas where pipe covering has been removed for maintenance work this material should have been replaced at the time when work was done. There are a number of valves, strainers and pipes which are High Pressure Steam operating at 148C which are contributing to the elevated temperature in this space.
