Salamander Inspections Ltd.
Mechanical Insulation Energy Audits

Energy Audit

Wascana Powerhouse

2405 Legislative Dr. Avenue C

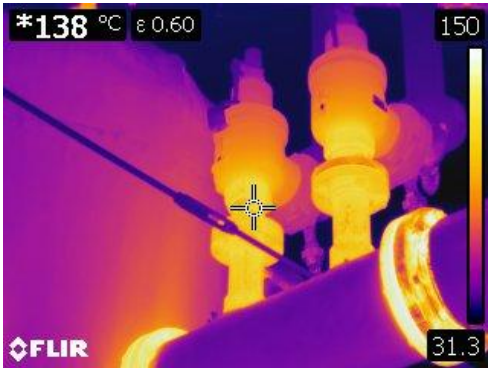
Figure 7 This is a thermographic image of a bare PSV at 138° C or 191° F.

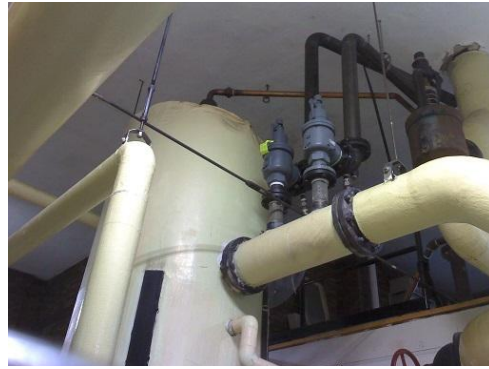
Figure 8 This is a conventional photo of the same piping and valve.

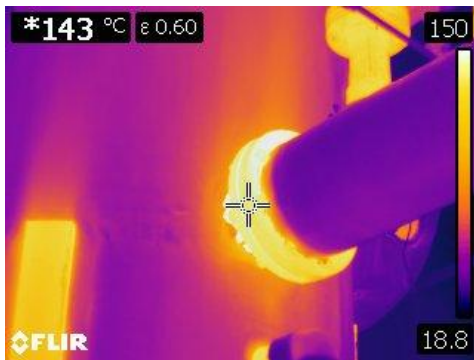
Figure 9 This is a thermographic image of bare flange in the powerhouse at 143° C or 290° F.

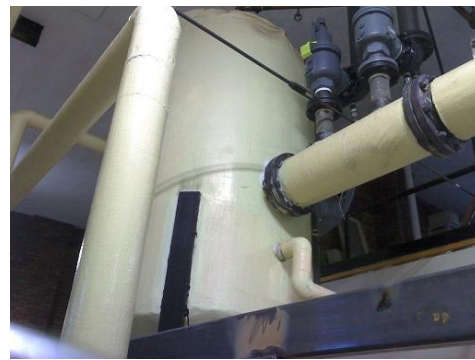
Figure 10 This is the conventional image of the same bare flange and piping.

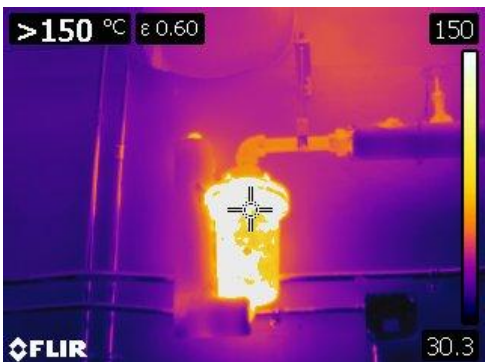
Figure 11 This is a thermographic image of a steam trap at a temperature greater than 150° C or 302° F.

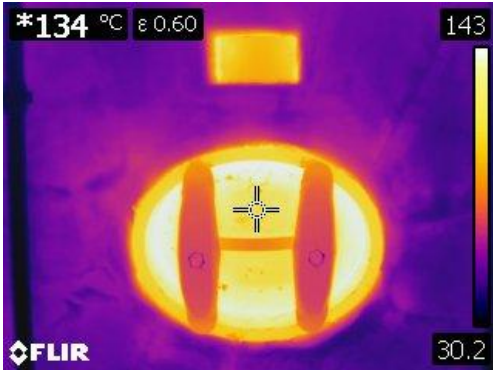
Figure 13 Thermographic image of a bare manway at 134° C or 134 °F

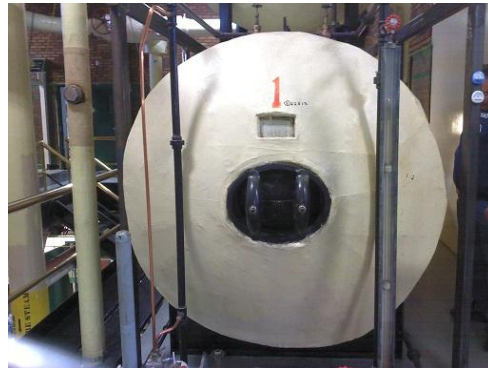
Figure 14 Conventional image of the same manway on tank.

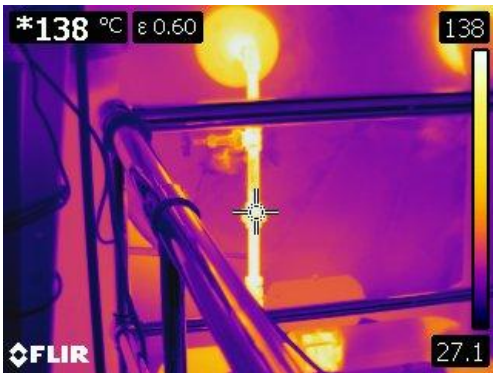
Figure 15 This thermographic image is of a bare pipe union at 138° C or 280° F

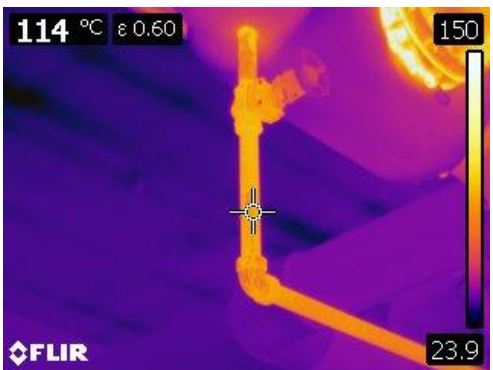
Figure 17 Thermographic image of unfinished elbows and piping at 114° C or 237° F

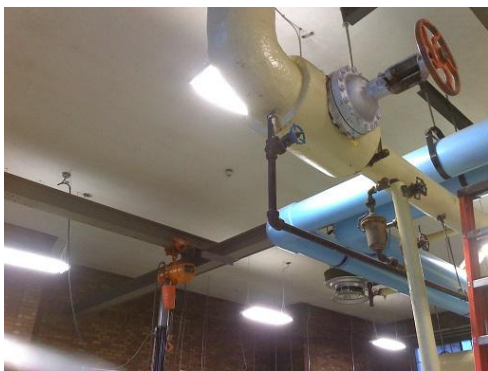
Figure 18 Conventional image of the same elbows and piping.

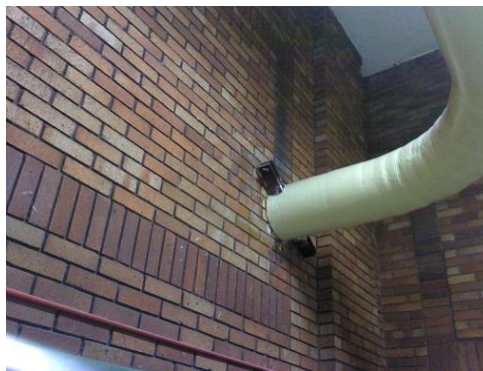
Figure 22 Conventional image of the same pipe support.

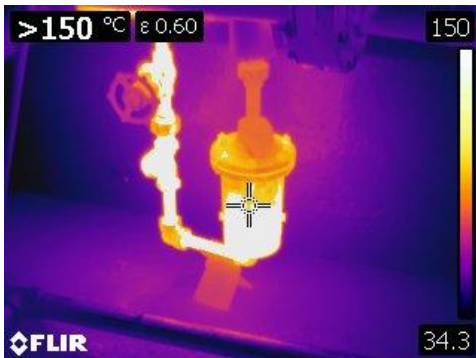
Figure 31 Thermographic image of a steam trap at a temperature greater than 150° C or >302° F.

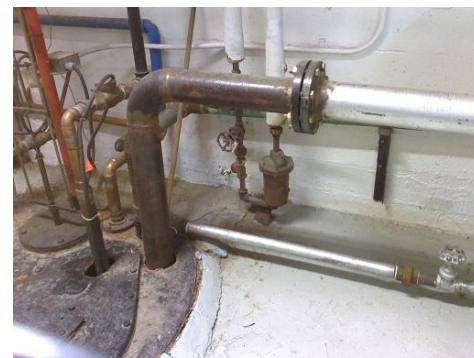
Figure 32 Conventional image of the same piping.

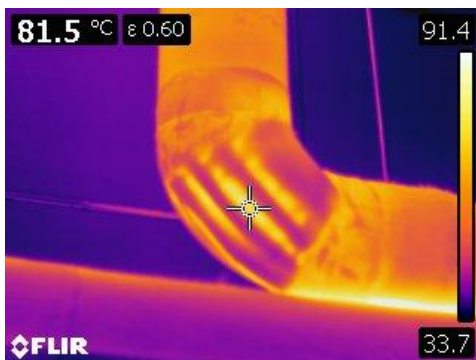
Figure 33 Thermographic image of an elbow with older fiberglass insulation and PVC covering at 81.5° C or 178° F.

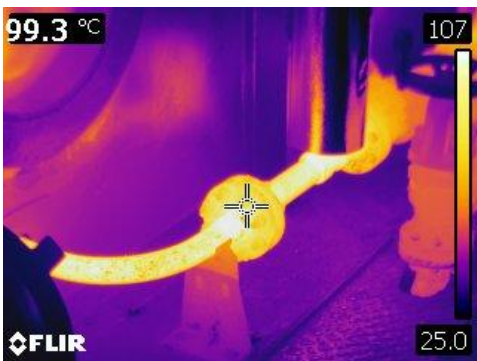
Figure 43 Thermographic image of bare pipe and flange at a temperature of 99.3° C or 211° F

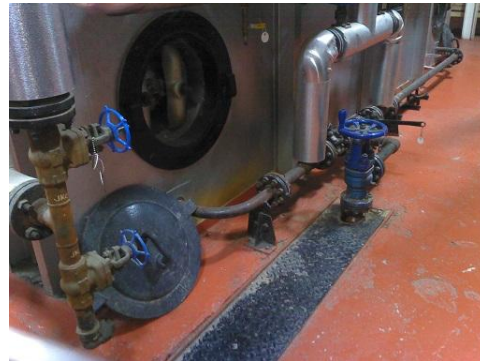
Figure 44 Conventional image of the same piping and flange.

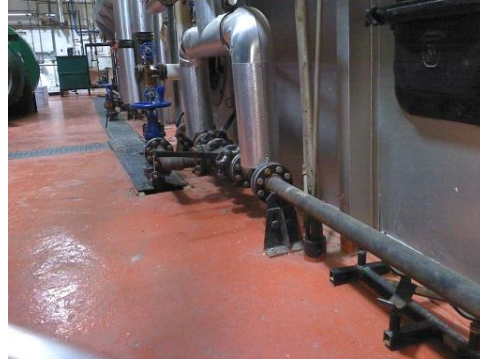
Figure 46 Conventional image of the same piping.

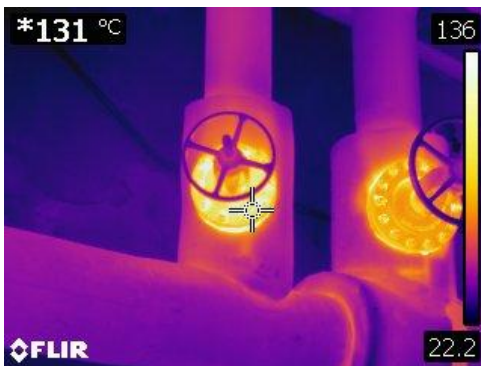
Figure 47 Thermographic image of bare valve bonnets at 131° C or 267° F.

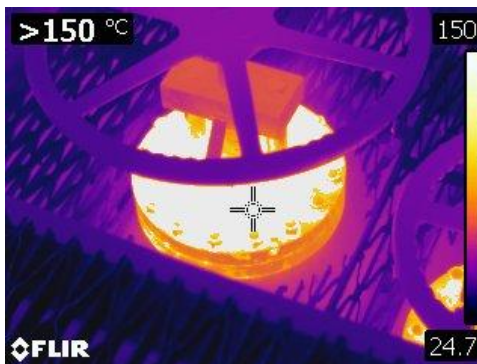
Figure 53 Thermographic image of a valve greater than 150° C or 302° F
