Salamander Inspections Ltd.
Mechanical Insulation Energy Audits

Energy Audit

Wascana Powerhouse

2405 Legislative Dr. Avenue C

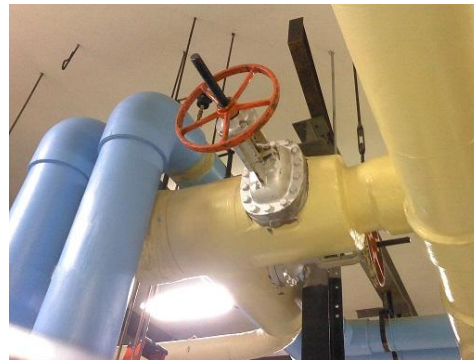
Figure 4 This is a conventional photo of the same exposed valve bonnet.

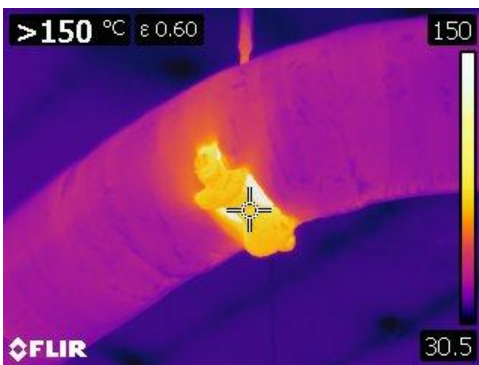
Figure 5 This thermographic image of a roller hanger at a temperature greater than 150° C or 302° F.

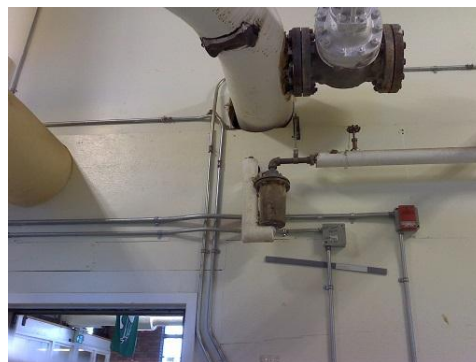
Figure 12 This is the conventional image of the same steam trap.

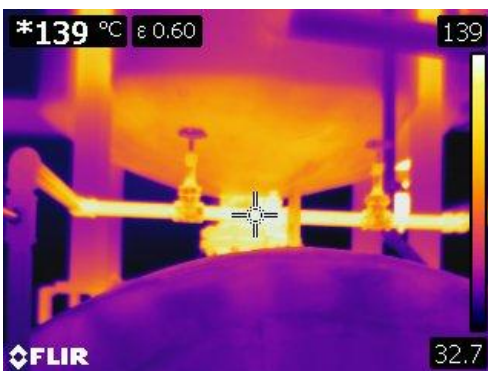
Figure 23 Thermographic image of a flange at 139° C or 282° F.

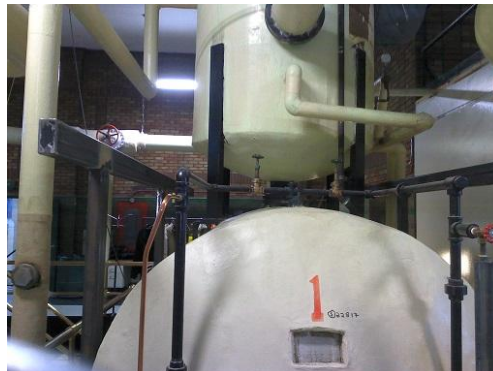
Figure 24 Conventional image of the same flange.

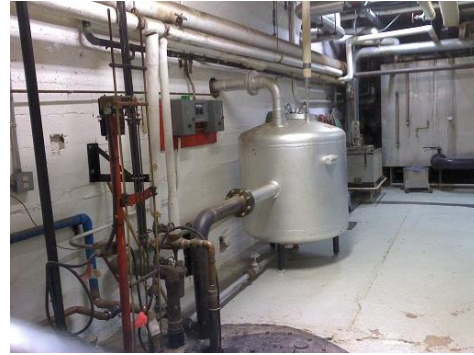
Figure 30 Conventional image of the same vessel.

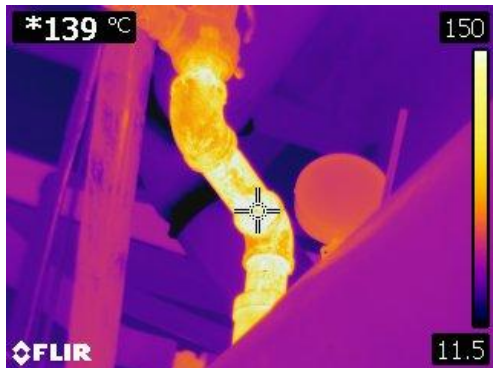
Figure 39 Thermographic image of bare copper pipe at 139° C or 282° F.

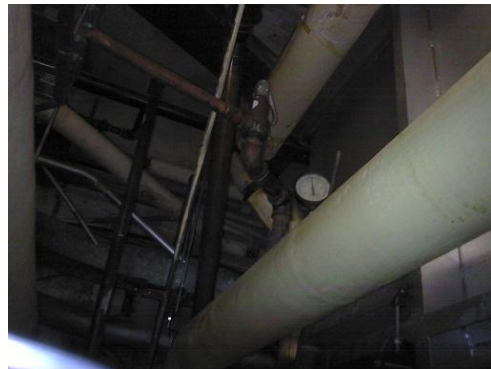
Figure 40 Conventional image of bare copper pipe.

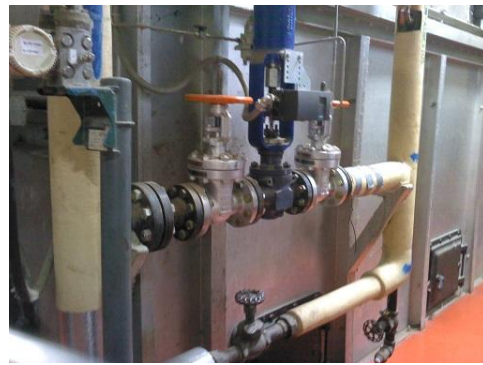
Figure 42 Conventional image of the same valve.

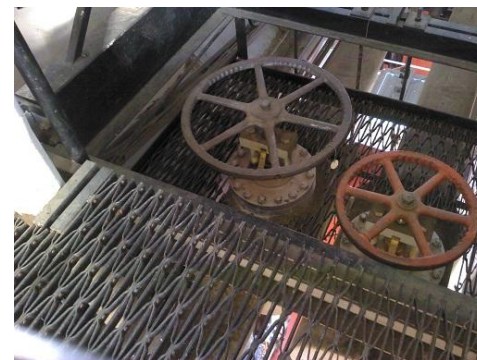
Figure 53 Thermographic image of a valve greater than 150° C or 302° F

Figure 54 Conventional image of the same valve.

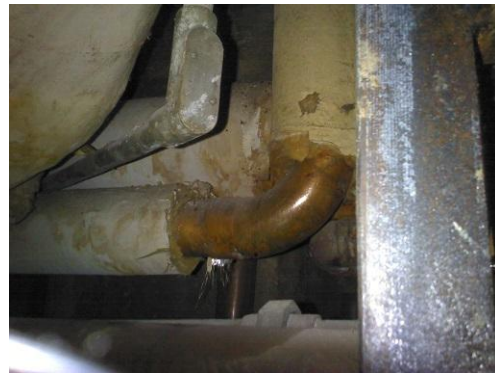
Figure 78 Conventional image of the same bare elbow.

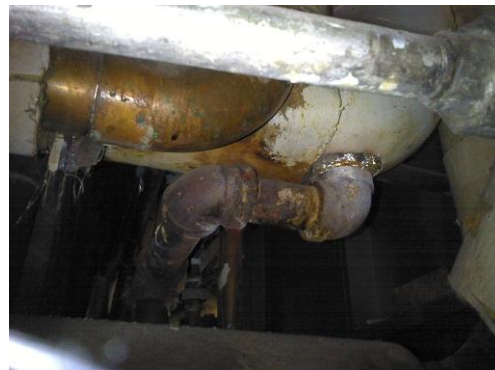
Figure 80 Conventional image of the same pipe.
